THE CHARACTERIZATION OF A CORRODED EGYPTIAN BRONZE STATUE AND A STUDY OF THE DEGRADATION PHENOMENA

Abstract

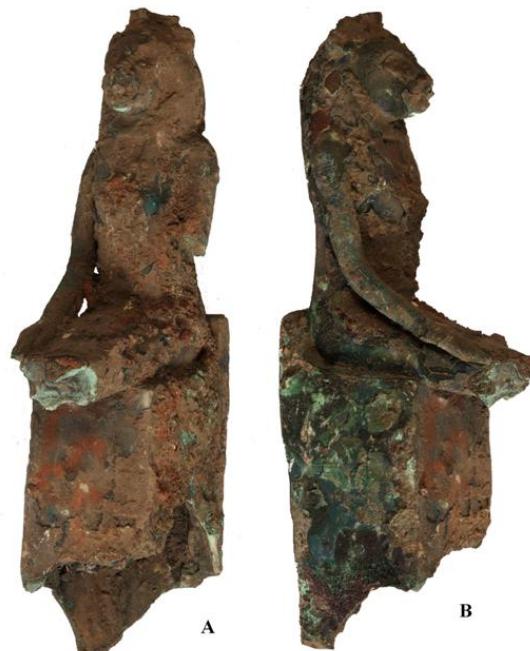
Fig. 1. The statue of Skhmet

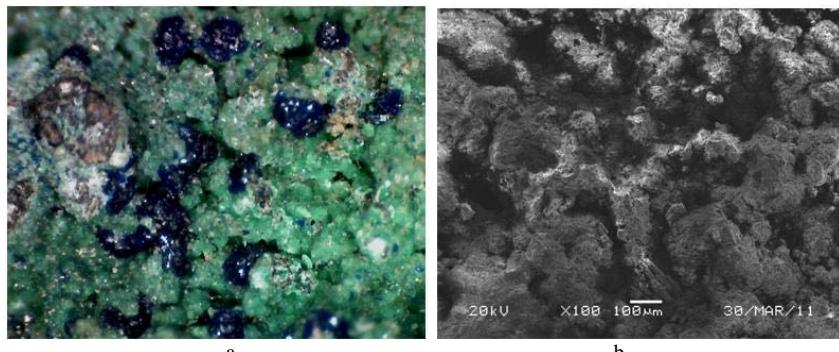
Fig. 2. The corrosion and contamination layer that has different colors on the surface:
a - optical observation (60X) and b - SEM image (x100)

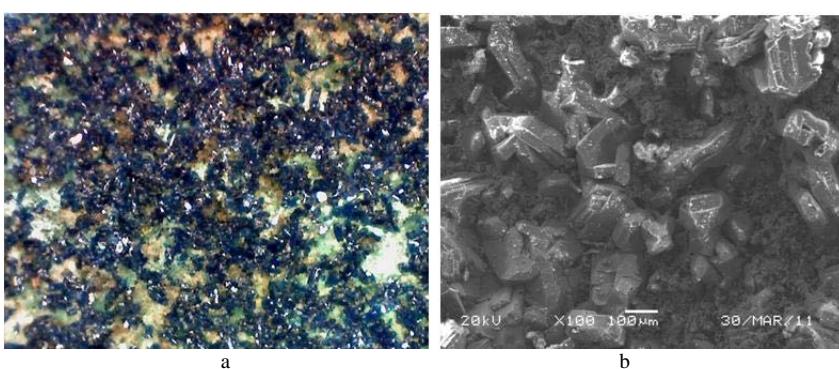
Fig. 3. The blue crystalline corrosion product sandwiches un-crystalline compound:
a - optical observation (50X) and b - SEM image (X100)

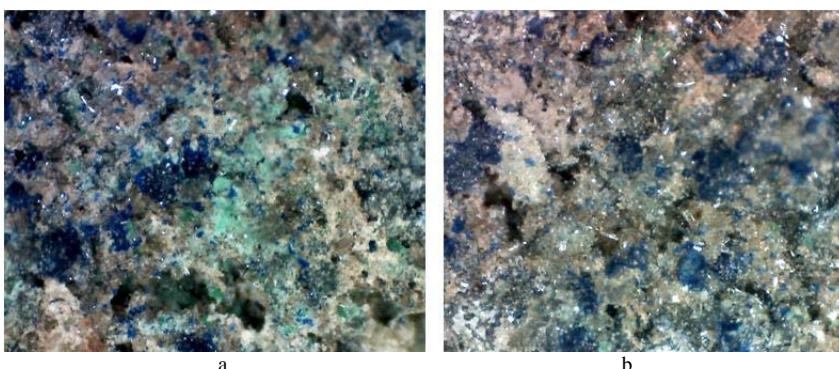
Fig. 4. Optical observations of the outer porous layer (100X)

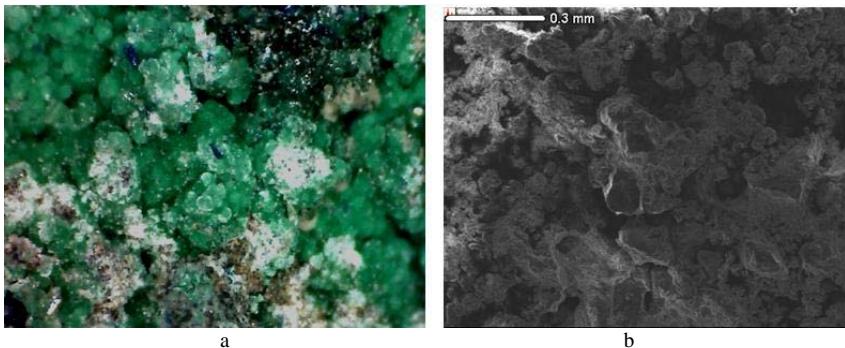
thick, in other parts the surface is covered in holes, where the soil residues have the color of the corrosion products and is interposed with them. The corrosion product of the green dark color, in some parts, has a shape like roes (Figs. 5), in other parts the light green colored product takes the shape of flakes, incorporated or covered with layers of transparent crystals identified as calcite (Fig. 6.).

Fig. 5. The green corrosion product on the surface: a - optical observation (60X) and b - SEM image

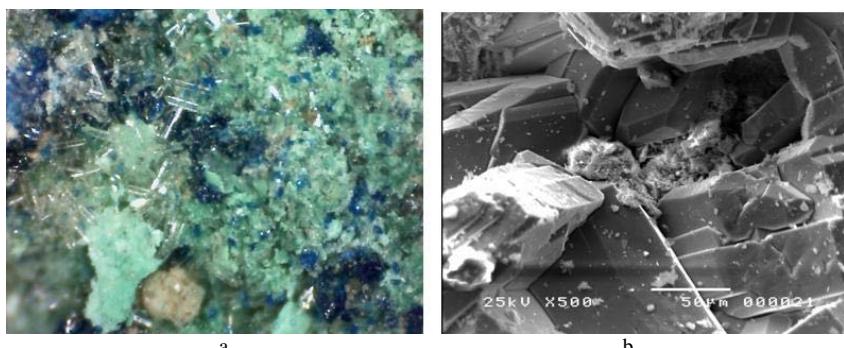
Fig. 6. The transparent crystals on the surface: a - optical observation (50X) of the outer layer and b - SEM image (X100)

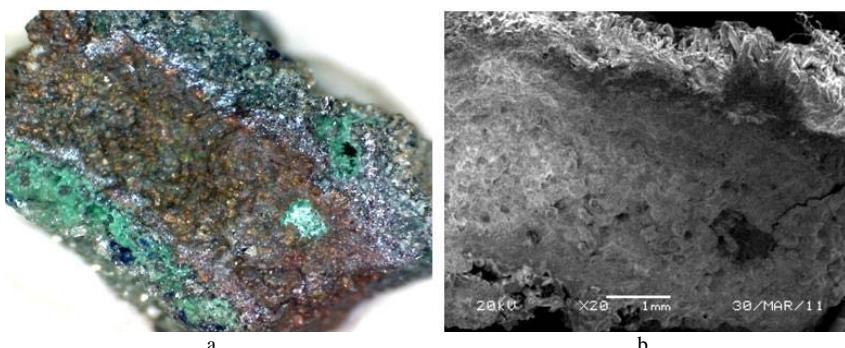
The microscopic investigation of the cross-section ascertained the strata-graphical morphology specific to most archaeological patinas of ancient bronze objects. That patina has a sandwich structure, in which the layers of the primary patina are overlapped or partially interposed with the ones of the secondary patina. The observation microphotographs (Fig. 7) show the colors, the thickness, and the layer morphology of the patina.

Fig. 7. The cross-section where the core of the alloy and the different features of the corrosion layers: a - optical observation (10X), and b - SEM image (X20).

The substrate has a reddish brown color, some reddish orange lustrous crystals and has some fissures and cavities. The first internal layer of patina layers, which in contact with the alloy is irregular in shape and thickness, is sometimes not observed, coherent and has a dark brown to blackish color, concealed beneath an overlying layer of green-blue basic salts, as

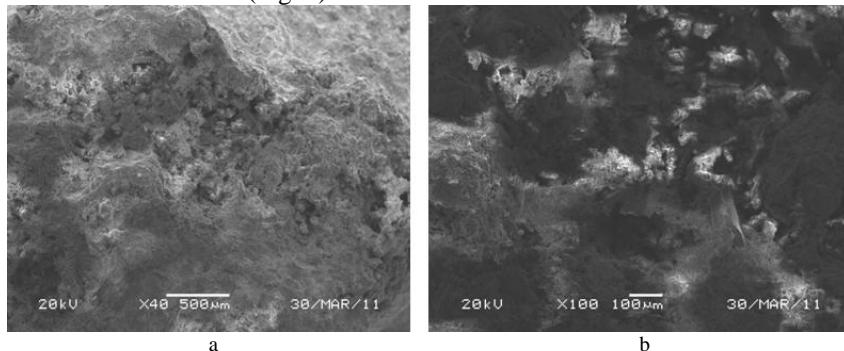
corrosion products. The later layer is thicker than the previous and is covered with an outer, even thicker layer that has amorphous compounds incorporated with soil crystalline compounds and covers most of the surface (Fig. 8).

Fig. 8. SEM images of the outer layer, soil residues covers the crystalline and non-crystalline corrosion products.

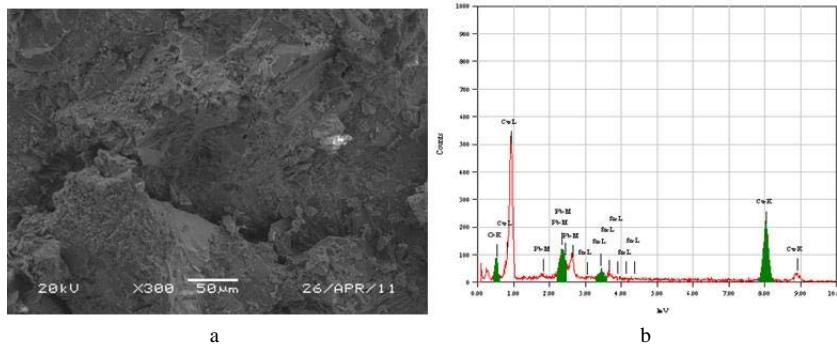
The elementary content revealed that the substrate or the alloy's core of the statue is bronze that contains a high percent of Cu (64.55 %,), turned to *Cuprite* in most parts where O is the minor element (18.42%), together with Pb (9.40%) and Sn (4.43%) as shown in Figure 9.

Fig. 9. SEM and EDS analysis of the alloy's core, in which a mosaic-pattern cracking is noticeable

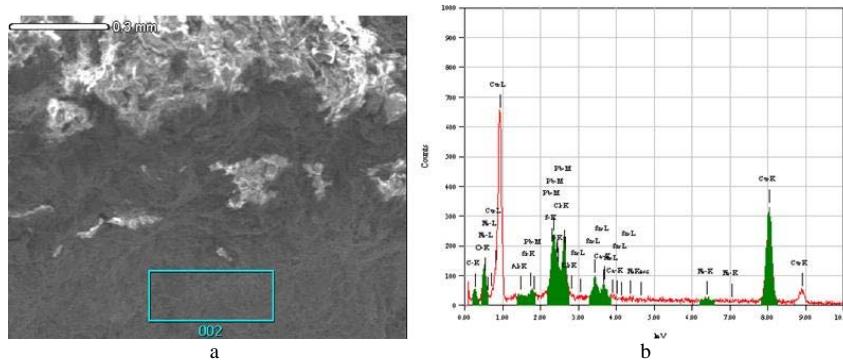
The internal layer (Fig. 10), is characterized by the presence of Cu, and Pb but less than in the alloy's core, (52.83 %) and (9.21%) respectively, and Sn (5.14%) somewhat higher than its content in the substrate, with O (18.51%), C (6.77%), Cl (4.21%), S (1.51%) and Si, Al, Fe as traces that detected by EDS as elements issued from the corrosive environment. This layer most probably consists of cuprous oxide and contains noticeable amounts of carbon, and chloride. This result has been explained by Lucey [9] considering cuprous oxide as an electrolytical membrane allowing the transport of oxygen and chloride anions inward and of cuprous ions outward. Cuprous chloride (CuCl) is also sometimes present sandwiched between the cuprous oxide layer and the substrate layer. The green-blue corrosion layer characterized by

Fig. 10. SEM (X100) and EDS analysis of the internal layer

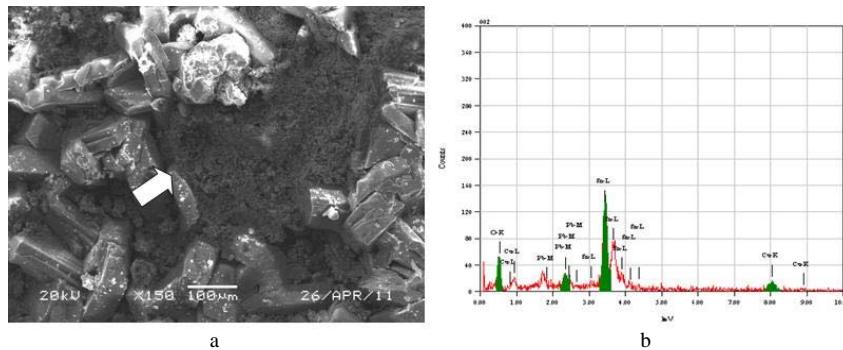
the presence of copper in a lower content, with respect to that in the alloy's core, and various content of lead and tin, except in the whitish to gray compound sandwiched between blue crystals (Fig. 11) where tin was much higher (64.27%). In this layer, the presence of elements from the corrosive environment, mainly O, C, Ca, Cl, S, Si, was clearly detected.

Fig. 11. SEM and EDS analysis of the sandwiched compound between blue crystals

Analysis of the blue color corrosion layer detected the presence of copper as the major element (47.28%), C (31.10%), O (17.08%), and Si (4.54%) (Fig. 14). While the gray sandwiched corrosion product between the blue crystals has Sn as the major element (64.27%), in addition to O (19.91%), Pb (8.04%), and Cu (7.78%). This is probably because of the deposition of tin oxide corrosion product (Fig. 11).

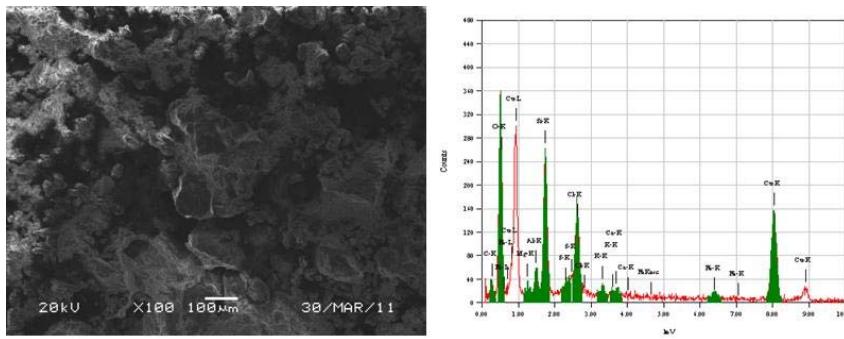
Analysis of the two samples of green corrosion product (Figs. 12 and 13) detected the presence of Cu as the major element (41.34% and 55.82%), O (24.39 -17.81%), C (14.32 - 15.19%), Si (14.32 - 2.19%), Cl (5.23 - 7.13%) respectively in the two samples, in addition to Al, Fe, Mg, Ca and S as traces elements. This indicates that this layer of green corrosion product of copper carbonate that confirmed by XRD analysis.

Fig. 12. SEM and EDS analysis of the green corrosion product

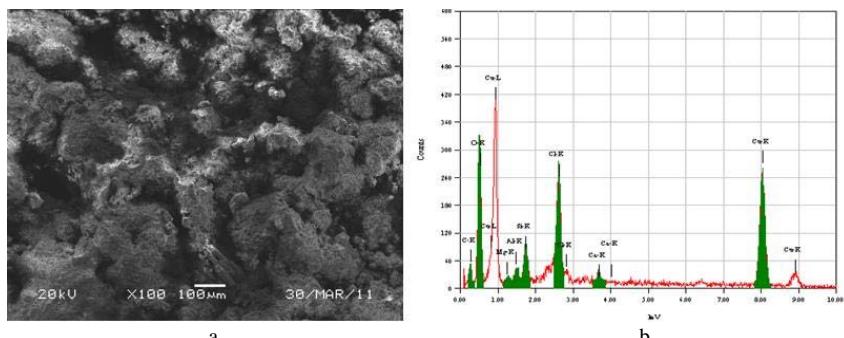
Fig. 13. SEM and EDS analysis of the greenish corrosion product

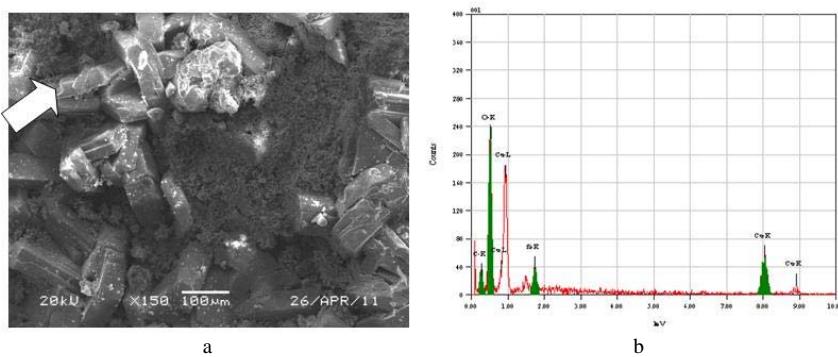
Fig. 14. SEM and EDS analysis of blue color corrosion

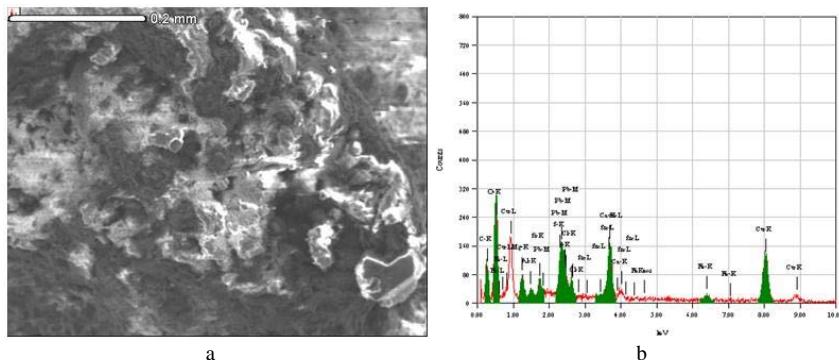
The greenish blue corrosion product that covered some parts of the statue characterized with the presence of copper in a less content (31.18%), C (24.97%), O (17.23%), Pb (11.24%), Ca (6.16%), Cl (1.42 %), Sn (0.25 %), besides Mg, Al, Si, and Fe as traces.(Fig. 14).

Fig. 15. SEM and EDS analysis of the greenish blue corrosion product

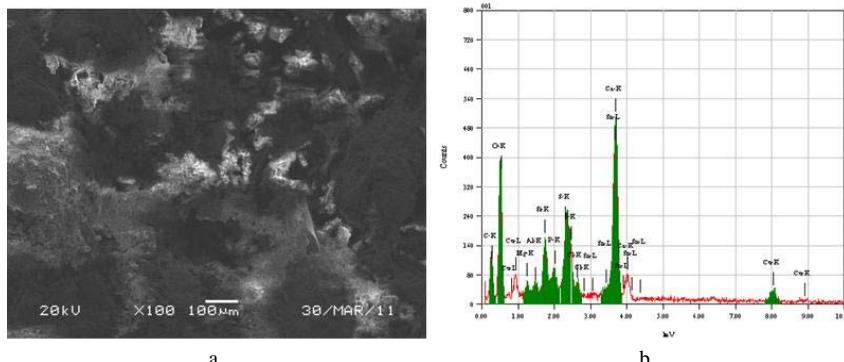
The outer layer is rich in soil elements and has the least content of copper and tin where there is not lead. EDS analysis detected the presence of C (29.82%), O (24.38%), Ca (23.16%), Si (3.93%), S (2.68%), Cl (1.52%), P (1.74%), Al (1.23%), Mg (0.86%), whereas Cu was

(8.60%), and Sn was (2.06%) (Fig. 15). Most of these elements were confirmed as carbonates, sulphides, chlorides and oxides by XRD analysis.

Fig. 16. SEM and EDS analysis of the outer layer rich in soil elements

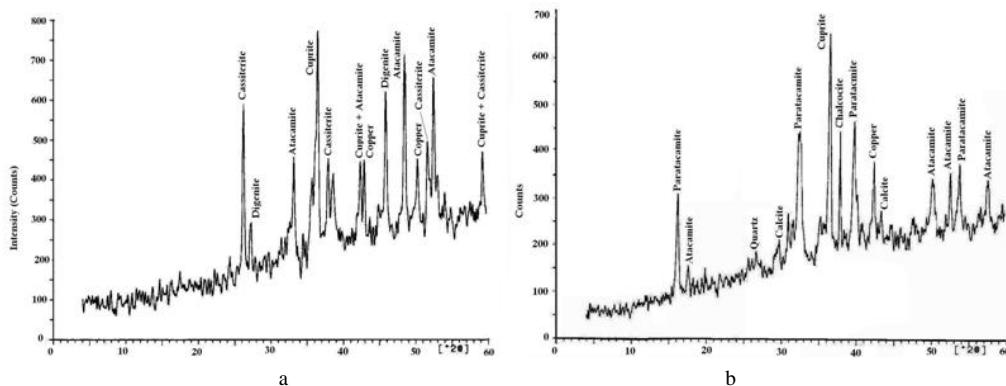
Cupreous oxide Cu_2O (Cuprite) was detected as the major compound in samples No. 1 (Fig. 17a), and No. 2 (Fig. 17b), a minor compound in sample No. 4, and as a trace in sample No. 5, and sample No. 6. This confirmed that *Cuprite*, the first and most widely occurring alteration mineral of ancient copper and its alloys, formed during burial, underground before excavation, as a result of exposure to oxygen or moist air [10]. The presence of metallic copper in the *Cuprite* patina in sample No. 1 and No. 2 may be from the dissolution of *Cuprite* formed during burial. The *Cuprite* layers that develop as a result of subsequent corrosion may also be subject to reductive processes, with formation in some areas of redeposited copper. *Cuprite* is known to play a decisive role in the protectiveness of corrosion layers on copper. But increase in oxygen pressure breaks its conformity and provoke its dissolution resulting in formation of flaws, through them Carbon dioxide and other various gases and ions are able to penetrate that favor local cell activity leading to amassment of basic copper corrosion carbonates, chlorides, and sulphates.

Atacamite - $\text{Cu}_2(\text{OH})_3\text{Cl}$ was identified as the major compound in samples 2 (Fig. 17b), 4 (Fig. 18b), and as the main compound associated with *Paratacamite* - $\text{Cu}_2\text{CO}_3(\text{OH})_2$, representing the pale green corrosion product. The latter compound was found also as a minor compound in sample No. 5 and as a trace amount in sample No. 1. *Atacamite* was found as the second component in the reddish brown *Cuprite* sample No. 2, this indicates that *Cuprite* is the inner primary layer that followed by the overlying Cooper (II) chlorides or may be a secondary compound resulting from hydrolysis of cuprous chloride - CuCl (*Nantokite*) when exposed to moisture or moist air. These compounds (*Atacamite* and *Paratacamite*) are formed as a result of exposure to a long contact with saline soil richer with chloride content at high moisture level. It is known that the Egyptian soil is rich in sodium chloride that is highly reactive toward copper and its alloys. They may occur as original corrosion products or as transformation products from CuCl (*Nantokite*) that can be oxidized to red cuprous oxide – Cu_2O (*Cuprite*) and bright green basic cupric chloride (*Atacamite*). The latter often is altered to a paler green powdery

Fig. 17. XRD pattern representing the patina of the surface: a – sample 1, b – sample 2

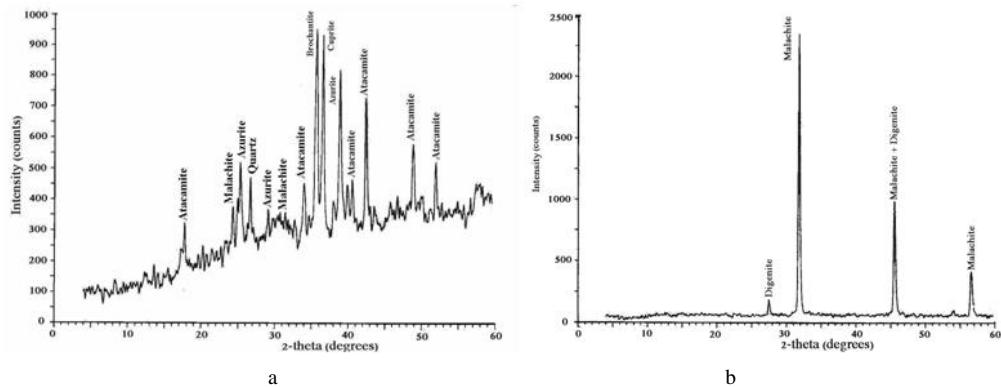
Malachite - $\text{CuCO}_3 \cdot \text{Cu}(\text{OH})_2$ was identified as the major corrosion product in sample No. 3 (Fig. 18a) representing a dark green layer, and as a minor compound in sample No. 5 (Fig. 19a) and as a trace in sample No. 1. While *Azurite* - $\text{Cu}_3(\text{CO}_3)_2(\text{OH})_2$ that has a similar composition to malachite, was less than *Malachite* as it was identified only in sample No. 4 (Fig. 18b) representing blue corrosion product. It is most likely that malachite and azurite are formed by contact with soil water charged with carbon dioxide or carbonic acid in poorly aerated soil [11]. Azurite as a patina mineral has been observed only on copper alloys that have been excavated from soil. And it is formed only from solutions with high concentration of hydrogen carbonate ion (HCO_3^-). The presence of azurite indicates that the object corroded in the presence of elevated hydrogen carbonate activity, which usually results from the dissolution of calcium carbonate CaCO_3 by CO_2 -rich water [12]. And this is the same condition that helps in forming lead carbonate *Cerussite* - PbCO_3 , which identified in samples No. 5 (Fig. 19a) and No. 6 (Fig. 19b), as a result of reaction of lead in the alloy with carbon dioxide. The rarity of *Azurite* in corrosion products, compared to malachite, is due to its lower stability than malachite and its ability to be converted to malachite in the presence of moisture through loss of carbon dioxide. [13].

Fig. 18. XRD pattern of: a - sample 3 representing the dark green corrosion product; b - sample 4 representing greenish blue corrosion product

The green basic copper sulphate - $\text{Cu}_4\text{SO}_4(\text{OH})_6$ (*Brochantite*) found as a major compound in samples No.4 (Fig. 18b) and No.5 (Fig. 19a), that usually reported on bronze artifacts exposed to sulfur-bearing waters or atmospheres. It is seldom to be found on copper alloy objects buried in soil. Also copper sulphides - Cu_2S (*Chalcocite*) and Cu_9S_5 (*Digenite*) were detected. The first one in sample No.1, and the second in samples No.2, 3, 6. This is probably as a result of burial oxygenated conditions, where hydrogen sulphide is evolved as a consequence of bacterial reduction of sulphates that utilize the oxygen for oxidative enzymatic activity from the microfauna present in the humus found in the soil sediments. Under this condition, sulfide ions are produced, thus giving rise to the formation of copper sulfides via the interaction with copper ions [13].

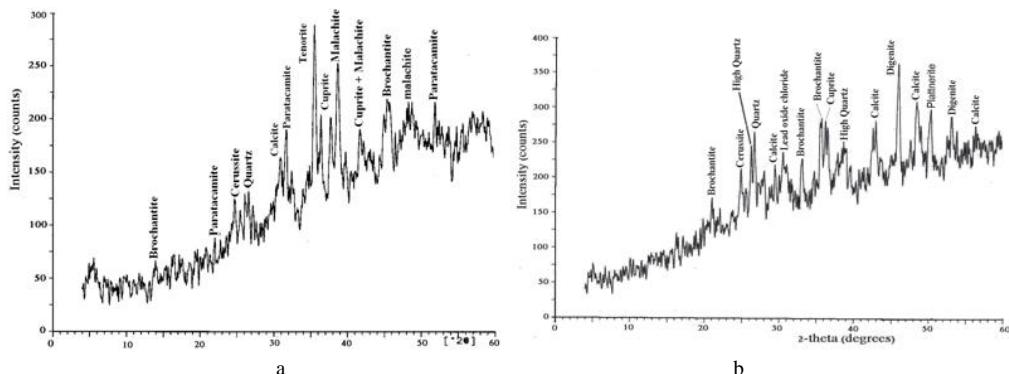
Calcite or calcium carbonate CaCO_3 was found in sample No. 6 (Fig. 19b), representing soil relics, incorporated with corrosion products and sample No. 1. This confirmed the EDS analysis of the outer layer rich in soil elements C, Ca and oxygen. However, it can't be deduced that the burial soil was calcareous soil as *Quartz* (SiO_2), the main component of sandy soil, was detected in samples No. 1, 4, 5, and 6. Also high *Quartz* was identified in sample No. 6. This means that the burial soil is most likely a mixture of sand and lime.

Fig. 19. XRD pattern of: a - sample 5 representing the dark green corrosion product; b - sample 6 representing the soil residues incorporated with corrosion products.
