OIL PAINTING COLLECTION: RISK ASSESSMENT, EVALUATION AND MITIGATION STRATEGIES

Mafalda FERNANDES, Sara BABO¹, Maria Filomena MACEDO^{1,2*}

Keywords: Preventive Conservation; Risk Assessment; Oil Painting; Historic House.

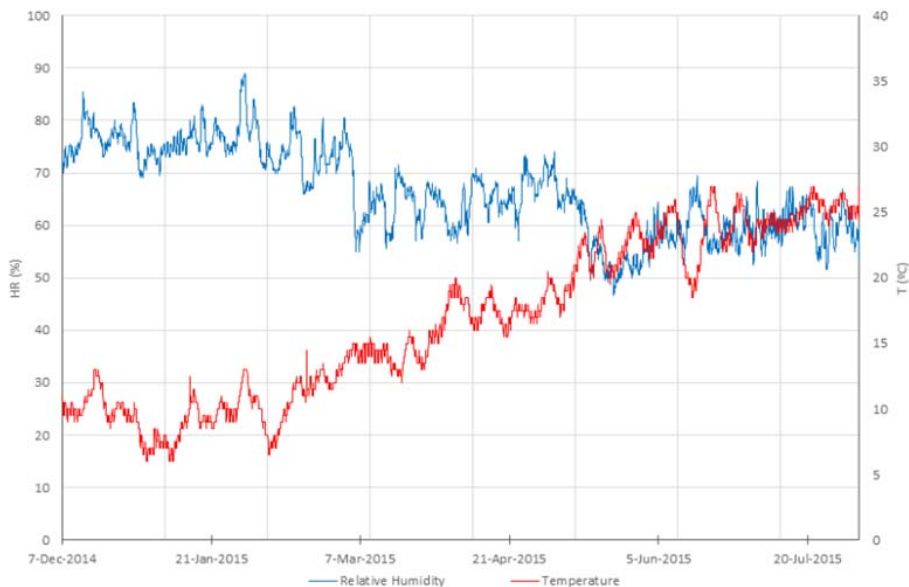
Fig. 4. Temperature (T) and relative humidity record from December 2014 to the end of July 2015 in the Green gallery (first floor).

Figure 4 shows the results from temperature (T) and relative humidity (RH) continuous measurements for a period of 6 months in the Green Gallery room (first floor). The data obtained for the other rooms are very similar, since there are no doors closed between the different rooms and the same air circulates all around the house.

As it can be seen by figure 4, the museum has a huge problem of relative humidity fluctuations. In the winter, the termohygrometers registered 90% RH in some rooms, and fluctuations of around 20% in only 48h were also observed. In the summer, the relative humidity levels are around 45% but it can go as low as 39,5%, as seen in Table 11. The museum has dehumidifiers in almost all the exhibition rooms. These equipments are working most of the time, but they are not capable of maintain a stable RH or within the levels suggested by the literature (Table 12). This is a common problem on historical houses, due to fact that, old, original windows provide poor insulation and the air from outside enters and circulates inside these historic houses.

Although average values of RH are between 62.4% and 66.4%, the problem is the huge difference between maximum and minimum values. The same problem occurs with the temperature values recorded (Table 11). Temperature inside the exhibition rooms has an average variation of 19°C between summer and winter. However, temperature values during the summer season are higher than 25°C. Those values are superior to the maximum values of temperature suggested in the literature (between 20 and 25°C) to prevent any damage to the objects [21].

$MR = 1 \text{ (FS)} \times 0.75 \text{ (LV)} \times 1 \text{ (P)} \times 139/235 \text{ (E)} = \mathbf{0.443}$. Although some paintings are more susceptible than others to the RH fluctuations, for example, if they have backing board they will respond to the RH slower than the ones without a backing board, to this MR calculation it was taken into account that all paintings were equally susceptible to be damaged by RH fluctuation. Other damages caused by RH fluctuations could be warping of the wood, causing undulations on the support; the oxidation of the nails that are tacking the canvas to the stretcher, cracking and consequently detachment of the paint. All paintings in exhibition that have these damages, were taking into account to calculate the extension of the damages.

There are several damages of the paintings as a result of fluctuation and maintenance of the collection at incorrect RH and T values. The first step in order to control these two agents of deterioration is to increase the windows and doors isolation, to reduce the air exchanged with the outdoor. The second step is to continue monitoring the environmental conditions with termohigrometers, to see if the first action together with use of the ventilation/dehumidification, in every room, will be enough to maintain the RH between 50% and 60% and the T around 18-20°C. The implementation of a HVAC system that allows controlling these parameters in a historic house is a very expensive and complex task, since it is not allowed to change the building aesthetic and the stability of the structure has to be taken under consideration. This is why the application of a HVAC system, in historic houses, is usually not recommended. However, there are some cases in which HVAC systems were successfully implemented in historical buildings in order to control RH and T [22]. Nevertheless, simple and low cost measures need to be considered first.
