DAMAGE ASSESSMENT OF THE ROMAN NYMPHAEUM IN AMMAN, JORDAN: AN ANALYTICAL AND DIAGNOSTIC STUDY

Abstract

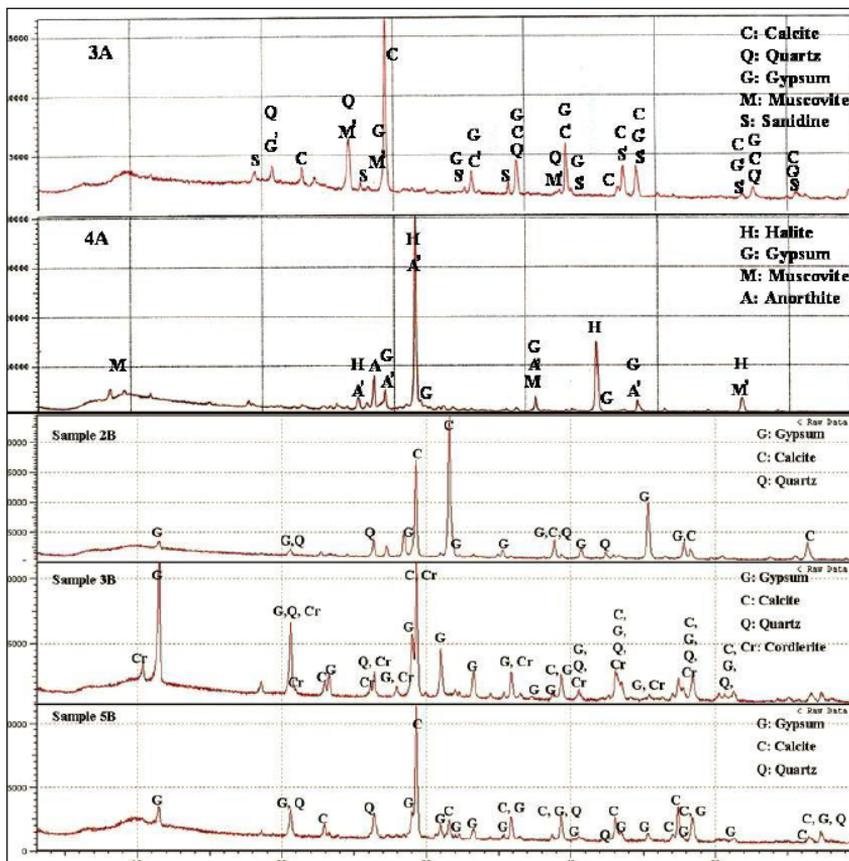
Fig. 1. XRD spectra for powder to medium hard samples for (3A, 4A, 2B, 3B and 5B).

The first group is the samples that are characterized by low hardness from dusty powder deposits to medium hard crusts and their color range from white to gray. This group consists of seven samples (3A, 4A, 5A, 7A, 2B, 3B and 5B), and contain Calcite (CaCO₃) as a major mineral. This is "except the sample 4A contains the Halite (NaCl) with traces of other minerals such as gypsum (CaSO₄•2H₂O), quartz (SiO₂), cordierite (Mg₂Al₄Si₅O₁₈), muscovite (KAl₂Si₃AlO₁₀(OH)₂), sanidine (K,Na)(Si₃Al)O₈), anorthite (Ca,Na)(Si,Al)₄O₈), beidellite (Na_{0.3}Al₂(Si,Al)₄O₁₀(OH)₂•2H₂O), and talc (Mg₃Si₄O₁₀(OH)₂), as shown in Figures 1 and 2.

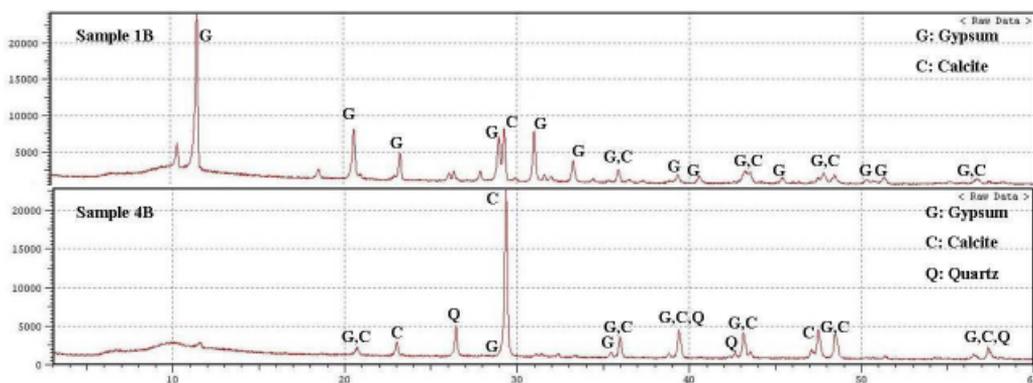
Fig. 2. XRD spectra for hard crust sample (1B and 4B)

The second group is the samples that are characterized by high hardness of crust layers and their color ranges from gray to dark, and this group of consists of seven samples (1A, 2A, 6A, 8A, 9A, 1B, and 4B), which contain calcite(CaCO₃) as a major mineral. This is "except the sample 1B contains gypsum (CaSO₄•2H₂O) as major mineral with traces of other minerals such as quartz (SiO₂) and gypsum (CaSO₄• 2H₂O), as shown in Figure 2.

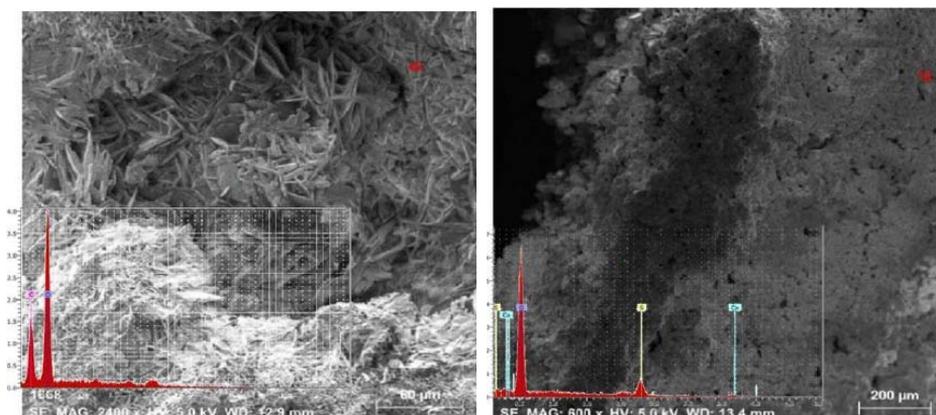
Fig. 3. Chemical characterization of sample (4B) By SEM with EDX

The chemical characterization of sample (4B) as in Table 3 shows the presence of (26.74%) carbon and (73.26) oxygen. The presence of these elements indicates the formation of a layer of hydrocarbon that resulted from direct burning of organic materials. The sample (7B) shows the presence of sulphur (12.87%), calcium (24.33%) and oxygen (62.80%). These elements give an indication on the formation of gypsum ($\text{CaSO}_4 \cdot 2\text{H}_2\text{O}$).

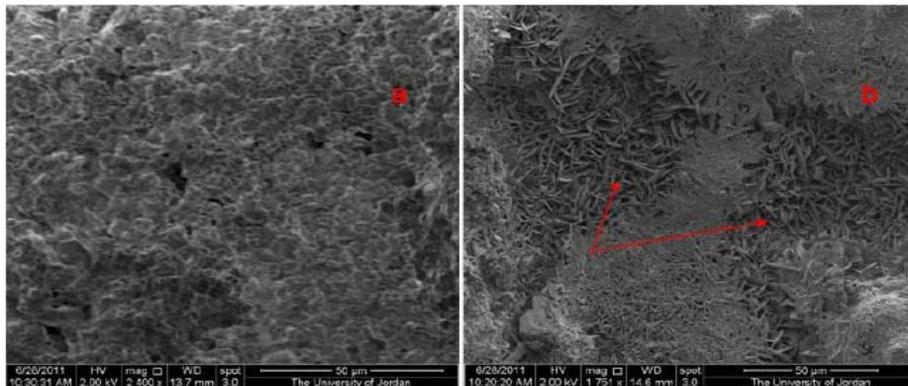
Fig. 4. SEM micrographs of sample (4B) a) showing the accumulation of Gypsum with calcite. B) Showing the needle like shape (gypsum) on the surface of the stone.

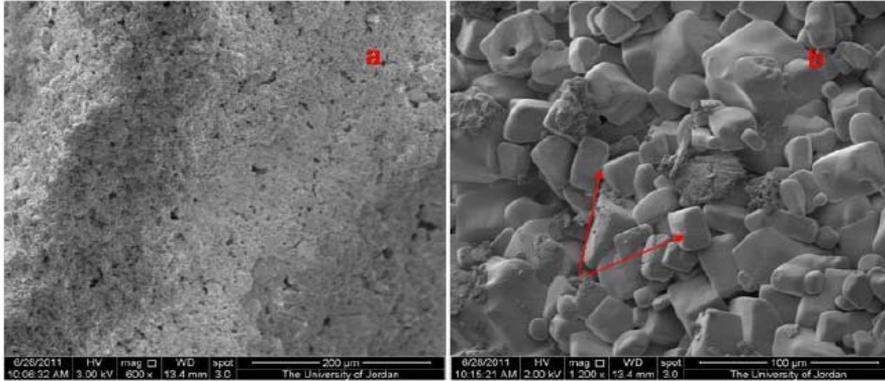
Fig. 5. SEM micrographs of sample (6B), a) show the surface of sample, b) showing the halite salt crystals.

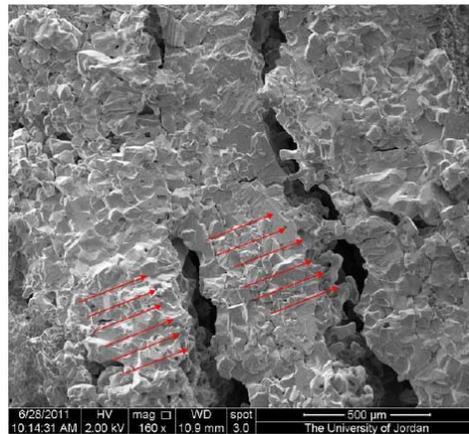
Fig. 6. SEM micrographs for sample (6B) showing the formation layers of Halite crystals.

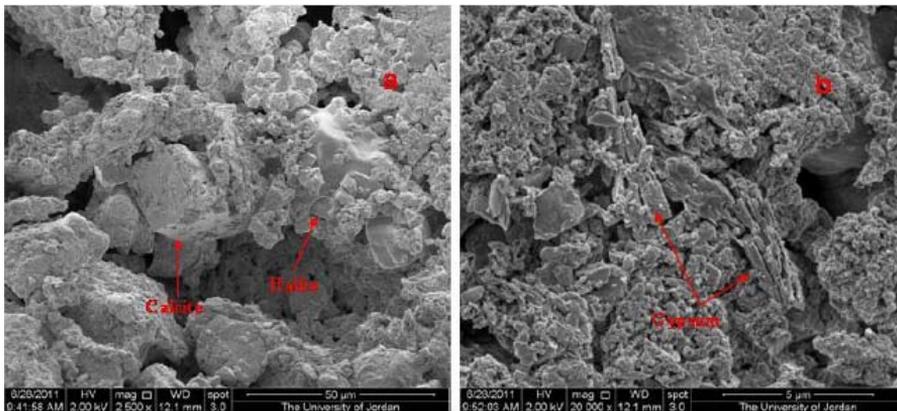
Fig. 7. SEM micrographs of samples (7B), a) showing traces of halite and calcite, b) showing the traces of gypsum.

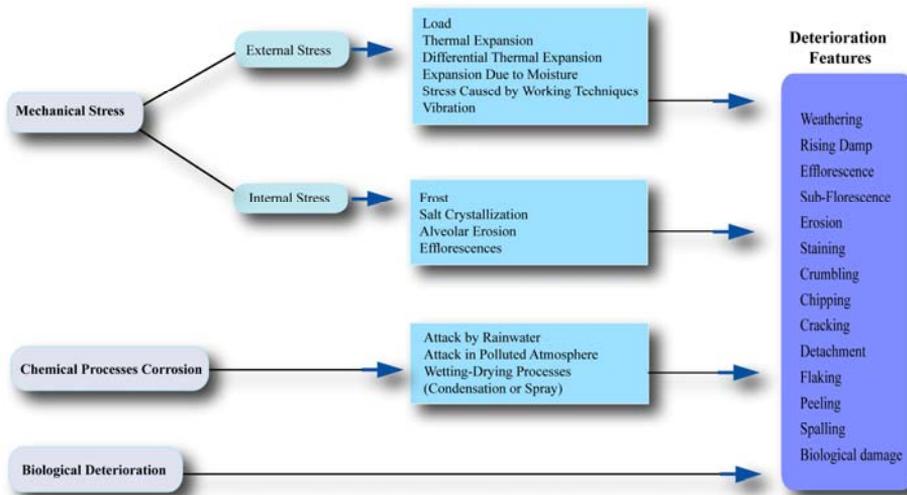
Weathering may have a degrading effect on the appearance and structural soundness of the Nymphaeum limestone. Factors include rain, snow, temperature, wind and atmospheric pollutants. Generally, these factors act in combination with one another or with other agents of deterioration (Fig. 8).

Fig. 8. Types of identified deterioration features at the Roman Nymphaeum in Amman

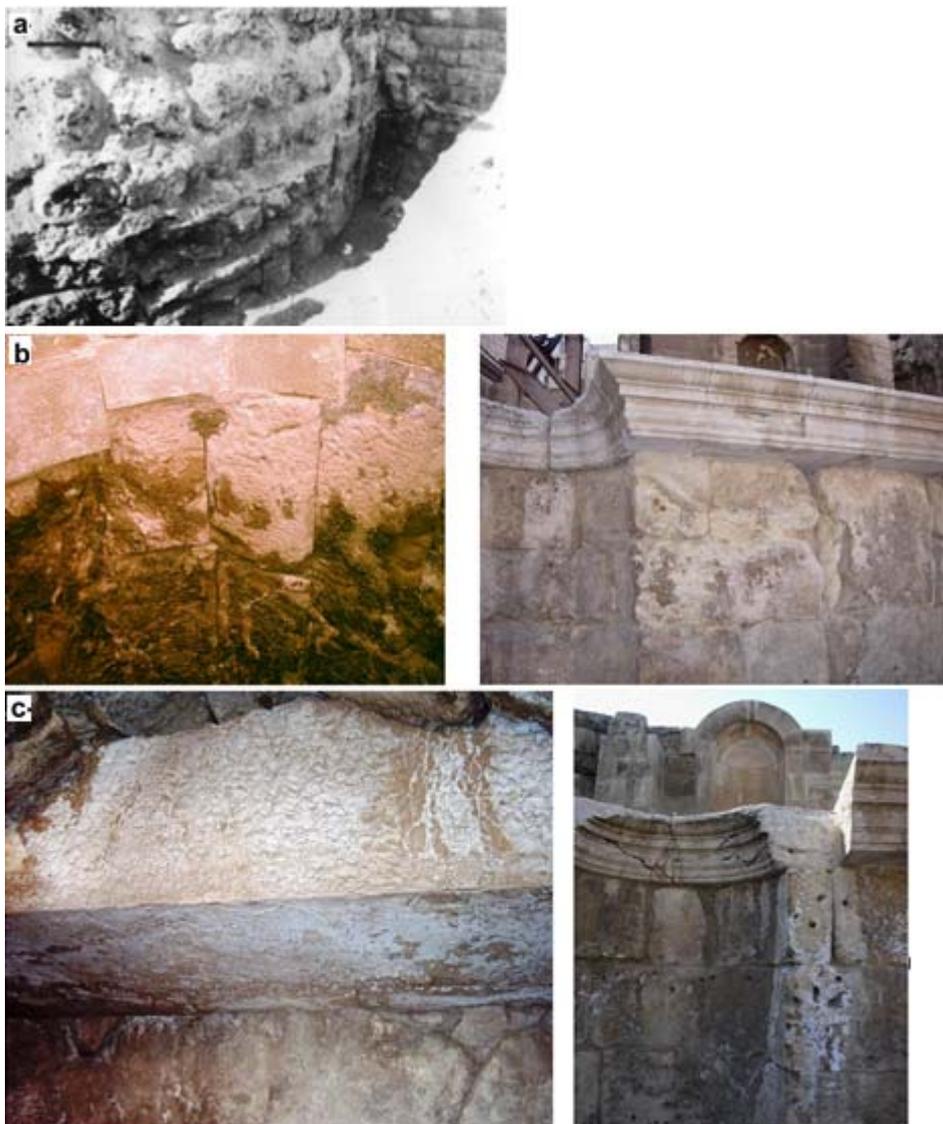
conditions within the Nymphaeum include weathering, rising damp, efflorescence, sub-florescence, erosion, staining, crumbling, chipping, cracking, flaking, and spelling. These cause general weakness and destruction to the monument, in addition to creating vulnerable parts, which are defined as critical parts of the structure, most of which are lost now (Figs. 9 and 10).

Fig. 9. Identification of the main deterioration causes and features at the Roman Nymphaeum in Amman: **a** – Weathering features in the lower part of the Nymphaeum, **b** – Rising Damp problem represented by the wet conditions of the stone, **c** – Efflorescence on the external parts of the Nymphaeum (right) and other features from the subterranean parts (left)

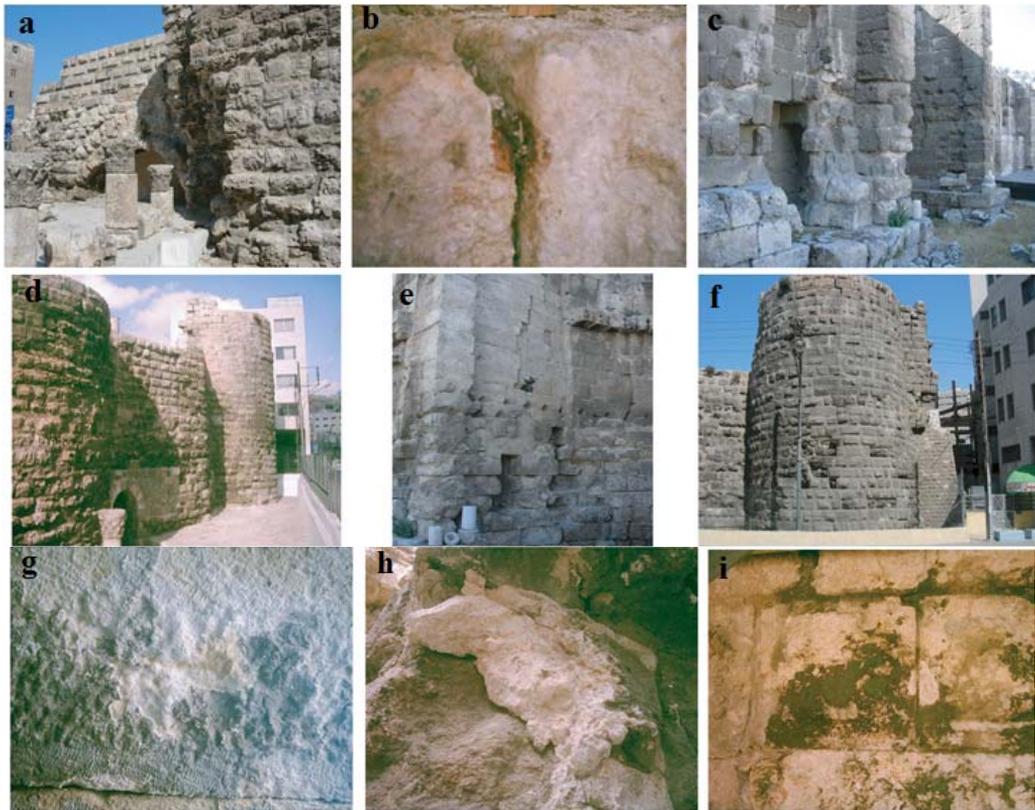
Fig. 10. Classification of deterioration causes and features at the Roman Nymphaeum in Amman:
a – erosion, b – staining, c – crumbling, d – chipping, e – cracking, f – detachment,
g – flaking, h – peeling, i – biological damage.

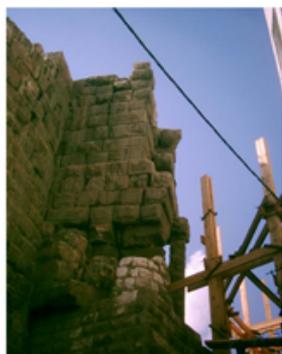
External Stress

Loads critical situation of the northern part after it was demolished

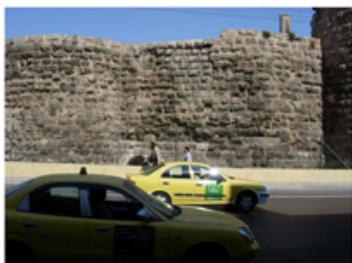
Attack by Rainwater and pollution

Main Street in the downtown passes by the Nymphaeum and forms a serious polluting source on the monument.
