EVALUATING THE RATE OF STONE ART DETERIORATION IN WADI MAGHARA AND WADI MUKATTAB, SINAI, EGYPT

Sayed HEMEDA^{1*}, Walid ALGHAREB²

¹⁾ Conservation Department, Faculty of Archaeology, Cairo University, Egypt,

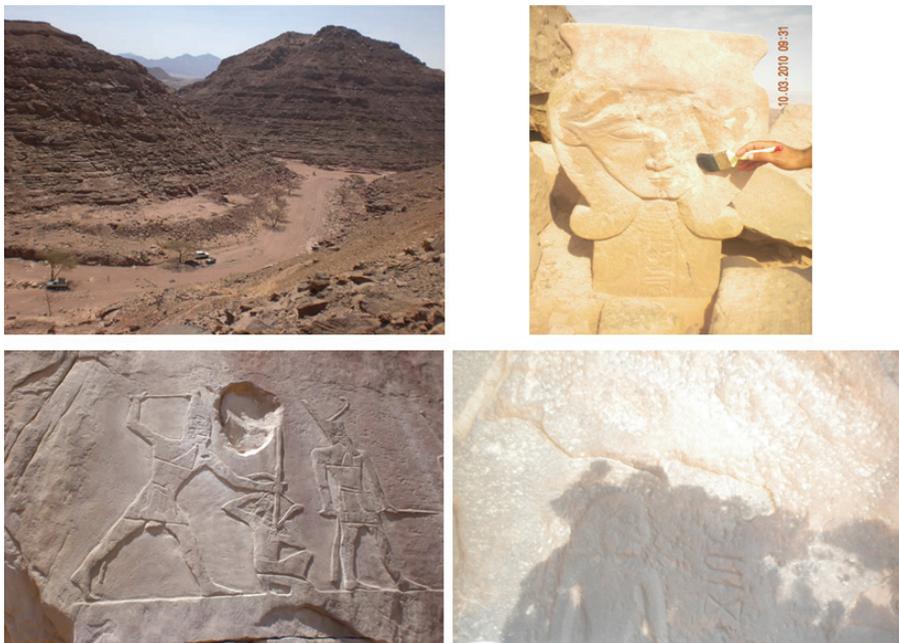
Fig. 1. Wadi Maghara inscriptions - present state.

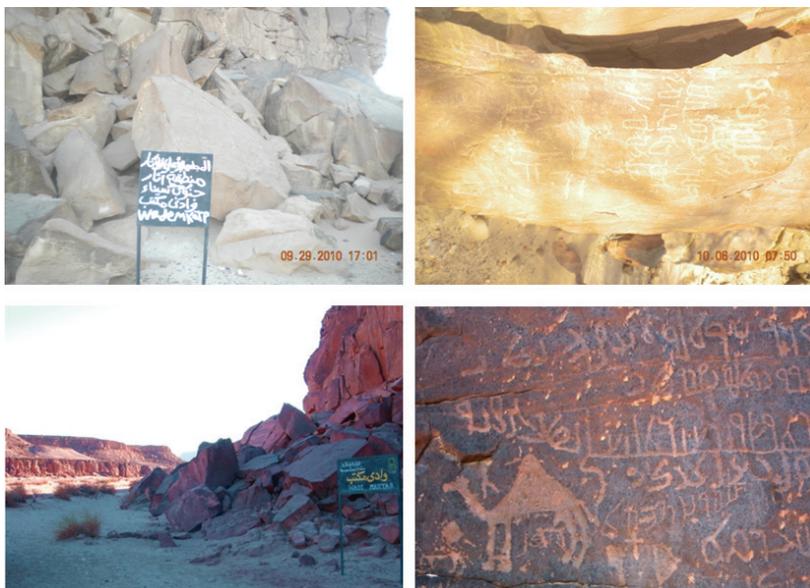
Fig. 2. Wadi Mukattab inscriptions - present state.
