## THE DETECTION OF COPPER-BASED PIGMENT DARKENING BY BIURET-REACTION IN MURAL PAINTINGS BY SEM-EDX, MICRO-XRF AND MICRO-RAMAN SPECTROSCOPY

*Micro-Raman spectroscopy, micro-XRF and SEM-EDX were applied to samples of baroque mural paintings in order to investigate a quite uncommon pigment alteration from azurite to tenorite by forming a biuret-complex which gives the painting a violet color. The detection of this discoloration gives the proof for the presence of protein and indicates the application of casein.*

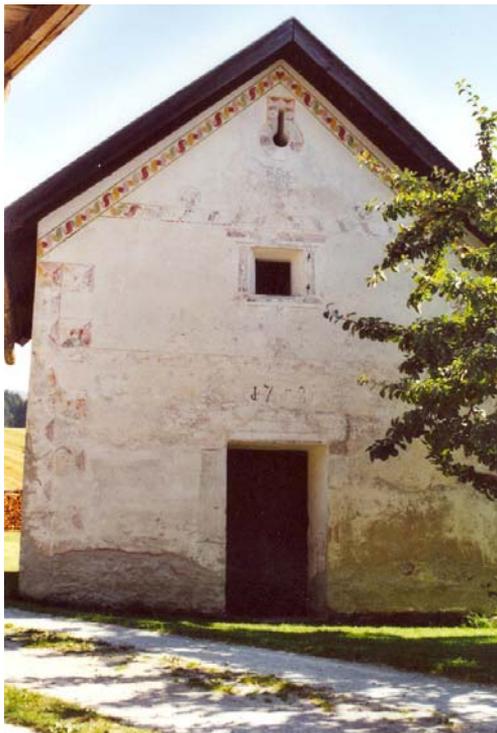
**Fig. 1.** Front side of the garner with ornamental mural painting which derives from the 18<sup>th</sup> century.

During of the preservation and restoration of a Baroque garner in the county of Salzburg in Austria (address: Zankwarn 8, 5571 - Mariapfarr), called “Galli-Kasten” (Fig. 1), preliminary investigations, which were carried out in 2009 for conservation purposes, revealed this uncommon alteration [12].

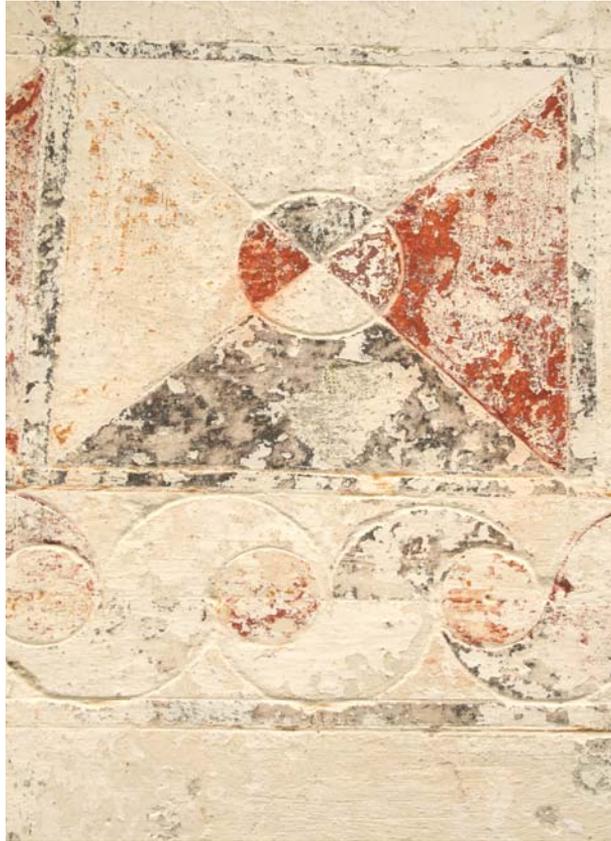
**Fig. 2.** Detail of the original wall painting with black and red pigments

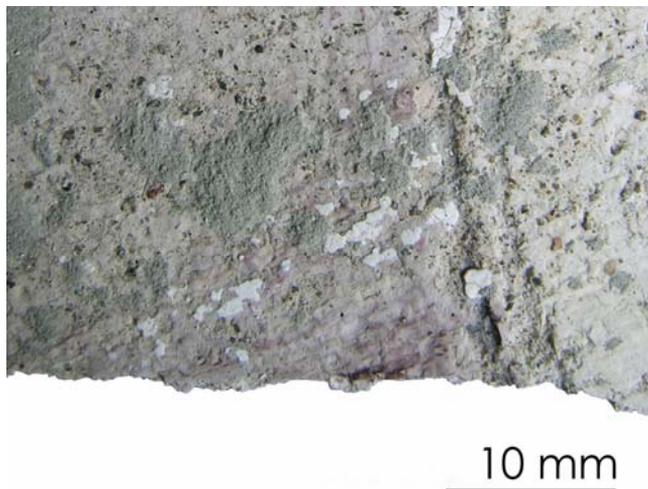
**Fig. 3.** A closer look at the black painted areas reveals a violet shading of the lime wash.

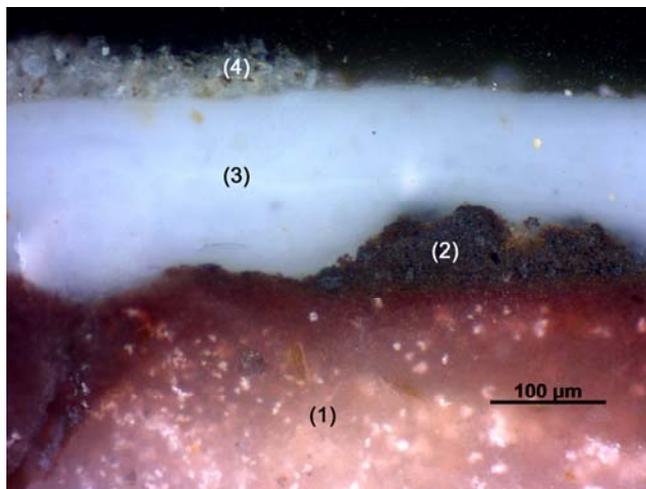
**Fig. 4.** Cross-section of the surface paint layers under the Light Optical Microscope.

Analyses, carried out by Optical Microscopy (Fig. 4) and by SEM (Fig. 5), show a final plaster, composed of a mixture of lime and silicate sand with a grain size diameter of up to

0.3mm. The plaster is covered by a 0.5mm layer of lime wash (number (1) in Figs. 4 and 5), containing some silicate grains with sizes up to 0.2mm. Remarkably, this lime wash shows an intensive violet colour which increases to the surface as can be seen in Fig. 4. This lime wash is followed by traces of black pigments (2), which apparently derive from pigment alteration. The detection of a layer of vitrification or densification respectively reveals that the pigment was applied by al-secco technique. The binding medium contains lime, however any further (organic) components cannot be concluded by SEM-EDX analysis. The painting is covered with a lime wash of approx. 100µm thickness, which was applied in two layers (3). According to the archives, mentioned in the introduction, this lime wash is assumed to be applied around 1900. The SEM image in figure 5 shows fragments of a thin hydraulic plaster (4), containing granulated cinder on the surface which apparently was applied in 1967. Analyses, carried out by SEM-EDX reveal that no traces of sulphation or any other salts could be observed in the complete sample.

As the conversion from azurite into tenorite is well known and has already been published so far [20], attention has to be drawn to the violet shading of the lime wash underneath the pigment layer. A prerequisite for this observed coloration is an alkaline reaction medium, which enables the reduction of the redox potential. Therefore, it can be derived that the copper pigments were applied on the alkaline lime wash before carbonation and that staining stopped when carbonation was completed. It seems to be implausibly that this colouration occurred when the second lime wash was applied on the pigmented surface by capillary moisture which shifted the colour complex into the sucking layer underneath as a sharp borderline can be observed between layers (2) and (3) in figure 4.

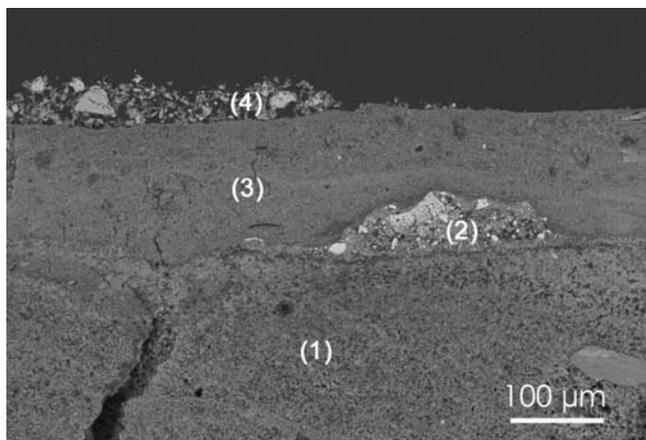
**Fig. 5.** Cross-section of the surface paint layers in the SEM in BSE mode.
