AN INTERDISCIPLINARY FIELD CAMPAIGN FOR MODERN INVESTIGATION AND MONITORING IN PRESERVATION AND RESTORATION

Laurentiu-Marian ANGHELUTA*, Dragos Valentin ENE

This paper describes the good practice demonstrations and results of an open restoration site organized at Tismana Monastery, Gorj County. For about two weeks an interdisciplinary team consisted in student restorers and research scientists joined their efforts to apply and demonstrate a model of good practice in modern restoration. This model is based on the infrastructure offered by the mobile laboratory ART4ART deployed on-site. The activities comprised non-invasive and non-destructive investigations and monitoring in several working areas with various casuistry. The list of modern technology used includes: laser induced fluorescence, multispectral imaging, 3D laser scanning, digital microscopy and ground penetrating RADAR. A long term monitoring of the microclimate (temperature and relative humidity) was also maintained. The purpose of the mixed working groups was to exchange knowledge between restorers and scientists through on-site course-like presentations and demonstrations. There were also tested the possibilities of

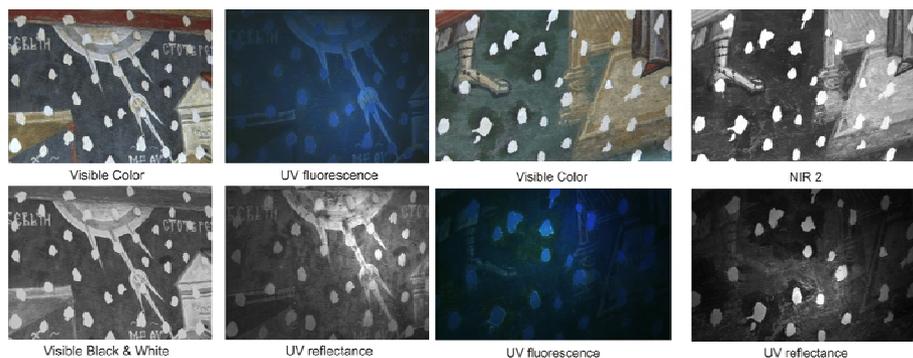
Fig. 1. Comparison of different recording modes used on the Annunciation scene

In UV reflectance mode we noticed two types of deposits. The first type is characterized by its staining aspect (these deposits are located next to the gaps produced by the hammer), while the others, small in size, with fragmented aspect and dark tonality, are disposed unevenly on the surface of the paint layer. It is important to notice that this scene was already cleaned during the restoration process. Both types of deposits, undetectable in the visible mode, are characterized by their high absorbance of UV radiation, a fact which may indicate the presence of an organic material. In this regards, additional investigations are required in order to confirm this supposition.

In UV fluorescence mode yellowish fluorescent halos were highlighted (they are not detectable in the visible spectrum). This fact indicates the presence of a material located at the surface of the paint layer, a material which is characterized by the property of being fluorescent when excited with UV radiation. By comparing and analyzing the multispectral recordings with

the coordinator-restorer we concluded that these halos were produced by a historical restoration intervention (dating from the second half of the 20th century) in which they used an organic consolidant, based on calcium casein.

The NIR 2 (near infrared) acquisition mode enables an ideal means to document the chromatic integration stage. This intervention, which is part of the restoration process, was performed in the case of paint layer lacunae (gaps) – with water based colors (reversible intervention).

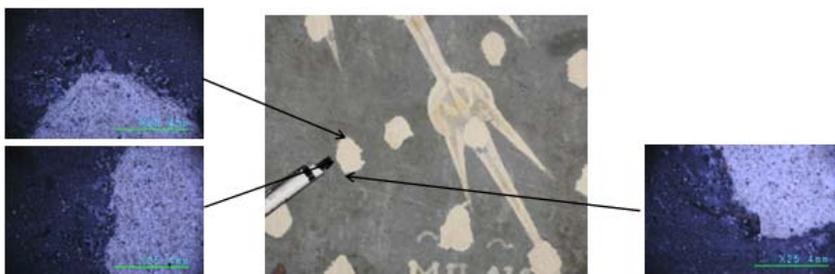
The microscopy investigations were carried out, following procedures implemented in past experiments [8], on 17 areas of interest, which were selected either after multispectral investigations, or due to some interesting visible characteristics. Two of these areas are presented in figures 2 and 3.

Fig. 2. Microscopic images (25X) for one of the filled gaps

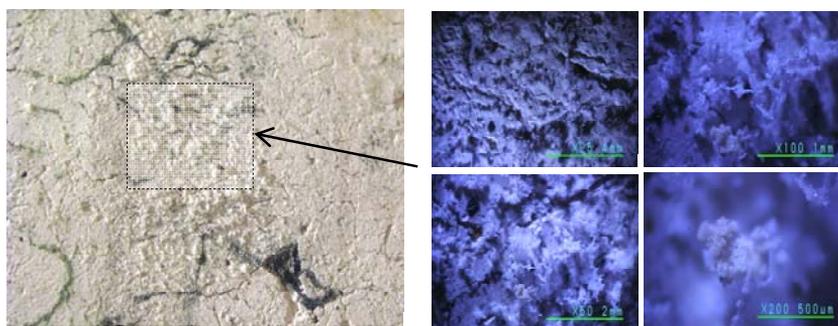
Fig. 3. Efflorescent salts – microscopy images at 25X, 50X, 100X and 200X magnification

The concentration of the salts present was determined by using a conductivity detector with a temperature sensor, needed for the calibration of the acquired data at standards' temperatures. The analyses were made on a surface of 1250mm² and the salt concentration was calculated at 1400mg/m².

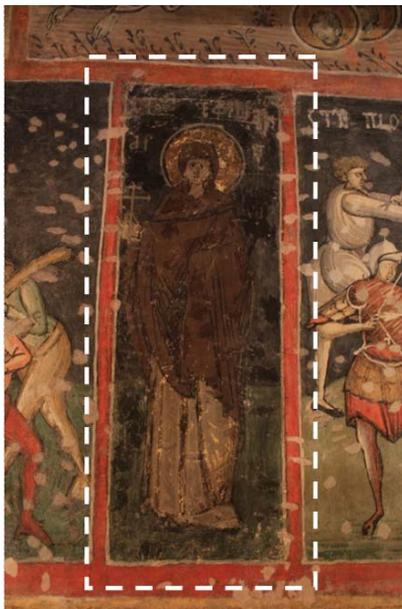
In the narthex on the first level of the scaffolding we chosen several scenes from the murals to be investigated with LIF. On the eastern wall we chose the St. Euphemia scene (Fig. 4).

Fig. 4. St. Euphemia scene selection

The bottom of the region of interest is located at 2 meters above the scaffolding level floor. The LIF system had to be installed at a height of 1.5m about floor level and at 1.2m from the surface of the mural. The investigations had to be done during the night in order to have the required darkness for fluorescence investigations. Several fluorescence spectra were recorded on special areas as indicated by restorer experts. Unfortunately the low energy laser (1.25 μ J/pulse at 266nm) was not enough to obtain a good and strong fluorescence signal from the murals.

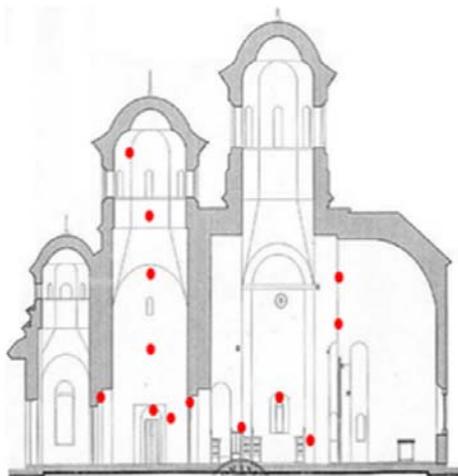
The positioning of the microclimate sensors (Fig. 5) aimed to measure the temperature and the relative humidity in different areas of the church. Seventeen synchronized sensors were used for monitoring with a recording frequency of 30 minutes. The data acquisition covered the period October 2013 – June 2014, obtaining a total of approximately 160,000 records. Minimum and maximum values of the two phenomena measured by each sensor are shown in Table 1 and Figure 5.

After analyzing the data we observed that all the sensors, except for one (S0 – from the temperature graph) show the same variation curve. Temperature variations were of 15-18 $^{\circ}$ C during the 8 months of monitoring.

The most important factor leading to the degradation of mural paintings is humidity. During the monitoring period high values, reaching 87.5%, were recorded. If high values of humidity are maintained for a long period of time salt migration and recrystallization phenomena may occur, decreasing the structural integrity of the color layer and causing

separations in the form of exfoliation. Also high values of humidity along with other factors can lead to biological attacks (emergence and growth of microorganisms).

Fig. 5. Microclimate sensors positions

The data obtained from monitoring the Church of Tismana Monastery revealed large temperature variations. Negative values of temperature and very high humidity inside the building are factors that can lead to degradation.

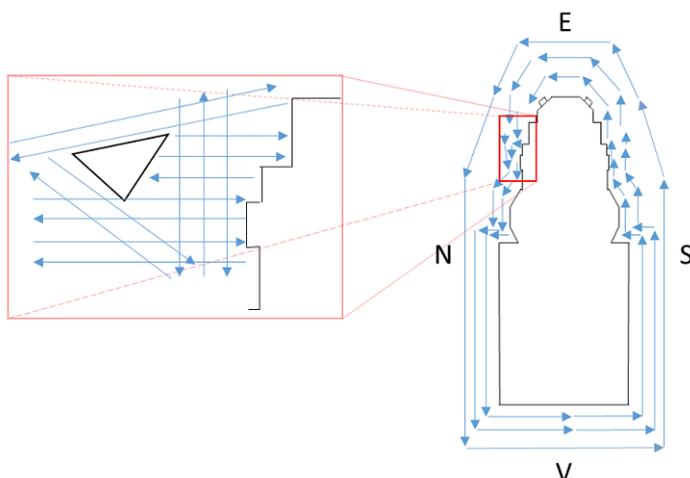
Three were taken three concentric turns of recordings were made at increasing distances from the church walls (Fig. 6), with each antenna, thus obtaining a number of 110 measurements. During scanning we observed that in the N-E side of the church there appeared more perturbations of the wave propagation, this leading to the decision of making another 30 investigations in this area, to gather more detailed data. After the processing and interpretation of all data, we noticed discontinuities of the soil dielectric characteristics and the appearance of some reflections in the shape of hyperbolas. The reflections represent the presence of some buried structures in the soil. There is a tendency of uniformity of the soil from the depth of 0.9 meters in almost all radargrams. The discontinuities that can be observed up to this depth may be due to older excavations carried around the church.

Fig. 6. Map of the recording tracks

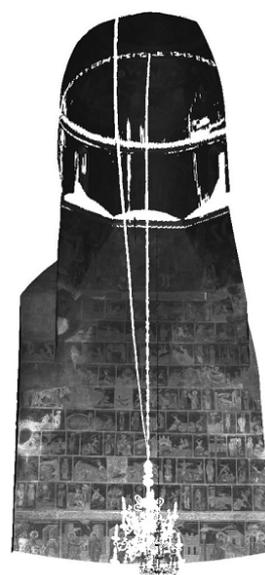
Fig. 7. 3D scan section

Scanning the interior of the Tismana Church is an activity that began in 2010 by measurements made in the narthex of the church and altar. Both sets of recordings were made before mural painting restoration [20]. Nevertheless we observed that some areas were not digitally captured and found two reasons for those errors. Firstly, the low reflectivity of the walls at the wavelength of laser radiation (690nm at 15mW power), absorbing much of the used light, so the reflected radiation, which carries the information on the relief of the surface, did not have sufficient quantity to be detected using by the 3D scanner.

In addition to the pre-intervention low reflectivity of the mural paintings there was the height of the perpendicular walls, which generated low incidence angles and thus, the reflected radiation was not detected by the 3D scanner.

The scanning system uses a principle of flight time, with one laser, so it cannot record RGB information about the scene, but only the object's reflectivity at the wavelength used. In the illustration you can observe the first 8 meters corresponding to the narthex painting could be recorded in gray tones (reflectivity at the wavelength of the radiation), unlike the upper areas where they could only record, in the best case, the relief of the surface.

These areas were recorded in a second set of measurements, during the campaign in July 2014, made for the upper areas by using the scaffold, while the lower areas benefitted by the high reflectivity of the already restored walls.
