## SUBMERGED VILLAGES. RECOVERING WALL PAINTINGS FROM THE CHURCH OF ATANCE (GUADALAJARA, SPAIN). TECHNICAL STUDY, EXHIBITION, AND 3D DISPLAY

*The construction of a dam often means losing the heritage of the villages that are caught beneath the rising waters. In the case discussed here, the inhabitants of the village of Atance (Guadalajara, Spain) saved their church and its contents by relocating it to the city of Guadalajara (Spain). The removal of an altarpiece in the church revealed a hidden niche covered in frescos. The niche had been walled up to erect the altarpiece. When the frescos were detached, they were found to have been laid on top of another painting, estimated to be as old as the church itself. We designed a novel system for displaying both sides of the detached frescos (with the impression left by the earlier work), preserving the shape and dimensions of the niche. This structure shows both the original and later paintings, together with the impression left by the original fresco on the back of the later depiction. Using virtual 3D imaging, the structure can now be viewed from all angles.*

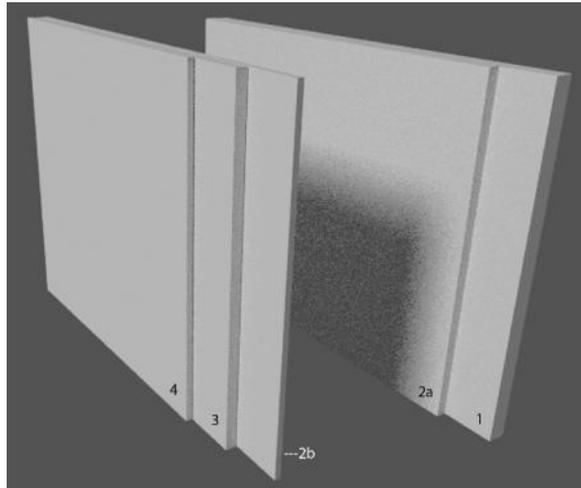
**Fig. 1.** Laminate wall paintings: 1 - Original mortar; 2a - Original wall paintings; 2b - Imprint of the original paintings on the back of the later paintings; 3 - Post mortar; 4 - Later murals

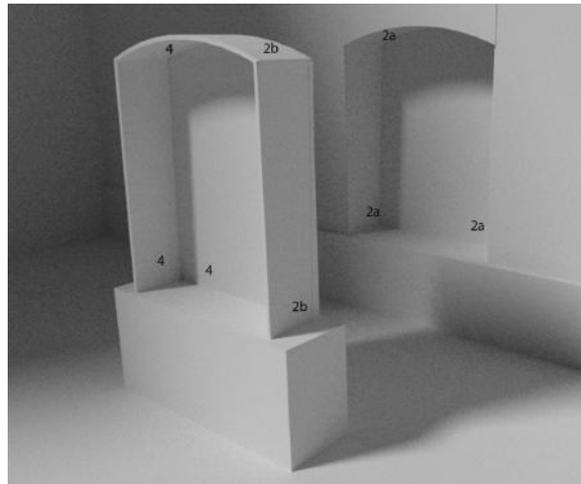
**Fig. 2.** 3D reconstruction. Murals situation in the original niche and back structure: 2a - Original wall paintings; 2b - Imprint of the original paintings on the back of the later paintings after starting; 4 - Later murals.

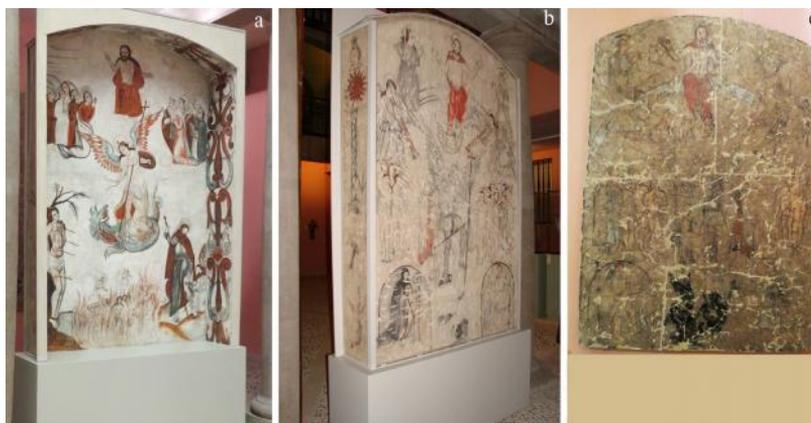
**Fig. 3.** The image of Jesus surrounded by angels with Archangel Michael, San Roque, San Anton, and San Sebastian:  
 a - Front of the niche with the later murals; b - Reverse niche with the imprint of the original paintings, older painting; c - Original paintings, older painting.

Both murals share a similar theme: the final judgment, with the Archangel Michael thrusting his spear into the dragon, the image of Jesus surrounded by angels, the depiction of various souls suffering in purgatory and the images of the saints San Roque and San Anton in the later paintings (Fig. 3a), and San Sebastian in the older work (Fig. 3b and 3c). The main

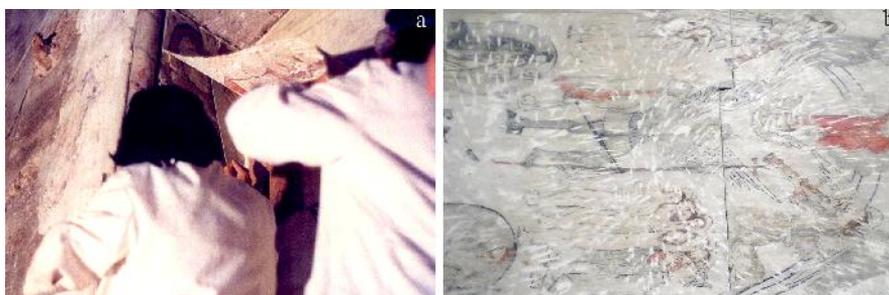
**Fig. 4.** Extracting mural: a - Starting the first layer of wall paintings with stacco method;  
 b - Detail of the back panel with two sections

Murals are, by definition, an integral part of the underlying structure. On the understanding, therefore, that the removal of a mural can jeopardize its integrity, preservation *in situ* must always take precedence over any other course of action. The case of the frescos discussed here, however, was exceptional, as urgent action was needed to save these murals. We chose the *stacco* technique to remove the murals, which allowed us to detach the paint surface together with the underlying plaster, thus preserving all the characteristics of the fresco [3]. The jambs and arch were removed *in bloc* (Fig. 4a), while the back panel, which measured  $230 \times 165\text{cm}$ , had to be divided into two interlocking sections (Fig. 4b). This system was chosen to facilitate the subsequent reassembly of the two pieces. Detaching the paintings from the arch was the greatest challenge, as this required building a frame of exactly the same size and shape as the original structure in order to preserve the original curve of the mural.

As mentioned, removal of the first paint surface revealed another, a much older painting underneath. The image of this painting was imprinted on the back of the overlying fresco (this is because in fresco painting, the pigments bind with the lime plaster, making it extremely difficult to separate one layer from the other) [4]. Once the first paint surface was removed, the second layer (the earlier work) was detached from the underlying surface using the same *stacco* method.

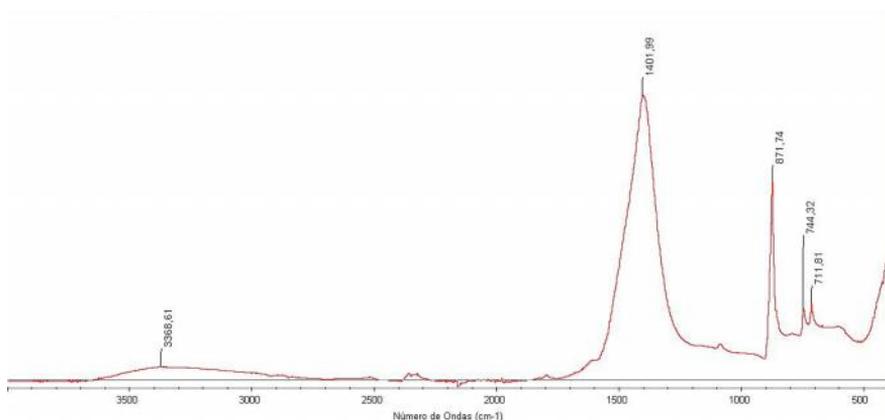
**Fig. 5.** Composition of the plaster. Spectrum FTIR - ATR sample mortar.

The ATR-FTIR spectrum showed the characteristic spectral bands of calcium carbonate ( $\text{CaCO}_3$ ): stretching vibration band of the  $\text{CO}_3^{2-}$  group (ca.  $1411\text{cm}^{-1}$ ) (wide, intense band) and the bending band of the group (O–C–O) (ca.  $872\text{cm}^{-1}$ ) (narrow and intense). Another characteristic band shown is cca.  $712\text{cm}^{-1}$  (weak and narrow). The band at  $744\text{cm}^{-1}$  has been assigned to dolomite ( $\text{MgCO}_3$ ). EDX analysis of the plaster identified mainly calcium (Ca) and magnesium (Mg), with a smaller amount of silica (Si) (Fig. 5). The presence of these materials clearly shows that the paint was applied using the fresco or mezza fresco technique, confirmed by OM.

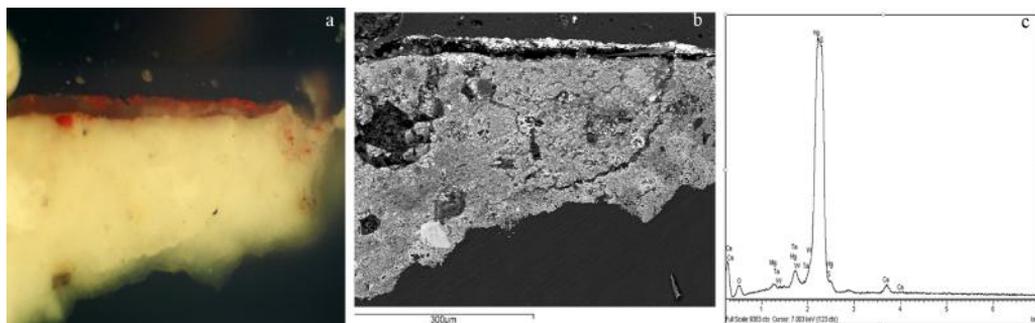
Under OM (500X), the sample of red pigment showed small particles of pigment mixed in with plaster (typical of fresco painting). The depth of the layer was  $30\mu\text{m}$ . Under SEM, we observed a moderately high density pigment which, under EDX particle analysis proved to contain elements such as sulphur and mercury. This confirmed the pigment to be vermilion/cinnabar ( $\text{HgS}$ , mercury sulphate), mixed with dolomitic calcite [ $\text{MgCa}(\text{CO}_3)_2$ ] as the binding agent (Fig. 6).

**Fig. 6.** Red pigment: a - vermilion/cinnabar. Observation by OM (epi - illumination) (500X). Detail picture layer and mortar; b - Observation by SEM (BSE).Detail mortar and painted layer; c - EDX microanalysis on film of paint/analysis of particle: vermilion/cinnabar mixed with calcite and sand.

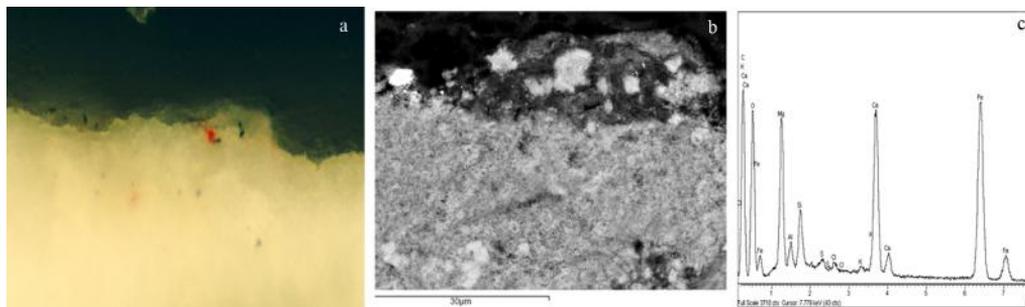
The pigment used to colour the flesh of all figures represented has the same technical characteristics: a very pale, flat colour, suggesting that very little pigment has been mixed with the lime [13]. Under OM, the paint layer was observed to be very thin (12µm), with the pink colouration being achieved by combining two different types of red pigment with the lime binding agent, both of which are present as isolated particles, in very small quantities. Under SEM analysis, these isolated red particles presented high electron density. The EDX elemental map (sulphur, mercury, iron, aluminium and silica) revealed these pigments to be vermilion/cinnabar (HgS) and an iron-rich red earth (aluminosilicates with iron oxide, Fe<sub>2</sub>O<sub>3</sub>). The characteristics of vermilion/cinnabar have been described in the foregoing paragraphs. (Fig. 7)

**Fig. 7.** Flesh: vermilion/cinnabar, red earth, calcite carbonate. a - Observation by OM (epi-illumination) (500X). Details of picture layer and mortar; b - Observation by MEB (BSE). Details of picture layer and mortar; c - EDX microanalysis on film of paint/analysis of particle: vermilion/cinnabar and red earth, mixed with calcite and sand.

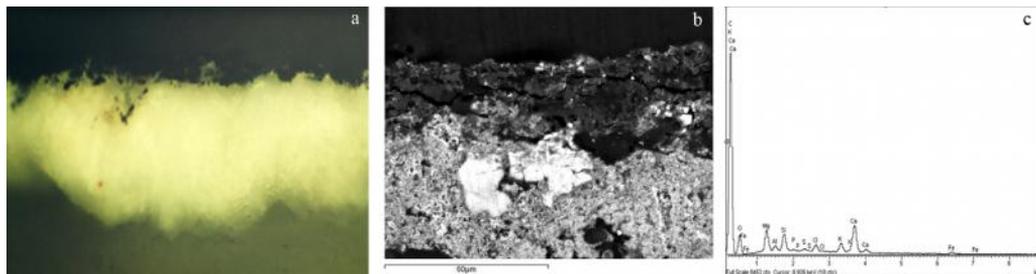
As can be seen on the OM and SEM images, the outline penetrates the plaster layer to a depth of 53µm. The colour was obtained from carbon black (C), a pigment with a very low electron density on SEM. EDX analysis (carbon, calcium, magnesium) confirmed that the black pigment is indeed carbon black, surrounded by calcite (CaCO<sub>3</sub>) mixed with dolomitic calcite [MgCa(CO<sub>3</sub>)<sub>2</sub>] (Fig. 8).

**Fig. 8.** Black pigment - carbon black: a - Observation by OM (epi-illumination) (100X). General image; b - Observation by MEB (BSE). Details of picture layer and mortar; c - EDX microanalysis on film of paint/analysis of particle: black coal back in dolomitic calcite.

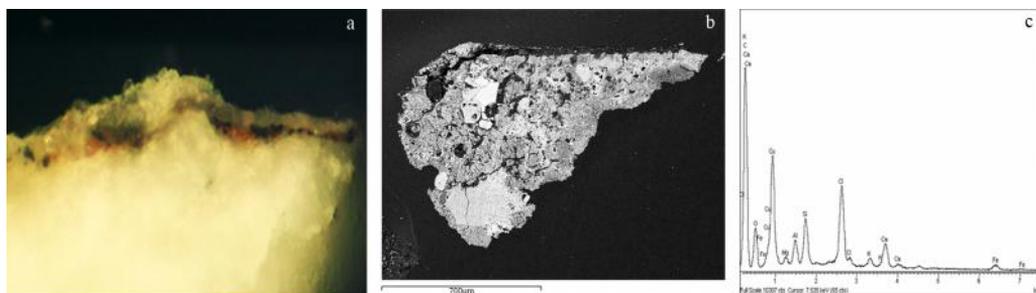
Under OM, the brown colour was found to be a mixture of different pigments in a single, very thin layer (26µm.). SEM analysis revealed a generally low electron density, with a few high-density particles. After examination under EDX (aluminium, silica, iron, mercury, sulphur, copper, chloride, etc.), we determined that the brown pigment was obtained by mixing red earth (aluminosilicates with iron oxide,  $\text{Fe}_2\text{O}_3$ ), vermilion/cinnabar ( $\text{HgS}$ ), *verdigris* ( $\text{Cu}(\text{C}_2\text{O}_2\text{H}_3) \cdot \text{H}_2\text{O}$ ), in other words, basic copper acetate, more or less hydrated, and a variety of *verdigris* called *viride salsum* ( $\text{Cu}_x\text{Cl}_y(\text{OH})_z \cdot n\text{H}_2\text{O}$ ), which contains chloride [15, 16]. The pigment is well integrated with the plaster (lime and sand), indicating that the correct fresco technique was used (Fig. 9).

**Fig. 9.** Brown color, vermilion/cinnabar, verdigris, viride salsum, black: a - Observation by OM (epi-illumination) (200X). Details of picture layer and mortar; b - Observation by MEB (BSE). General image; c - EDX microanalysis: *Verdigris (viridi salsum)*.

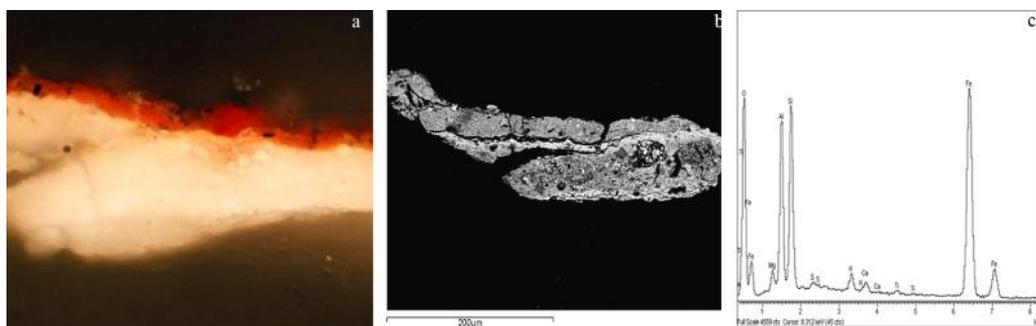
Under OM, this paint layer was seen to consist of a single stratum of dark red pigment with a mean depth of 25µm. It was obtained by mixing two pigments: red and black, the former in a higher proportion than the latter. On SEM analysis, some particles were found to have high electron density, corresponding to the iron content of red earth. This was later confirmed on EDX analysis, where we found iron oxide (Fe<sub>2</sub>O<sub>3</sub>) and to a lesser extent carbon black (C) (Fig. 10). As in other samples, calcite and dolomite binding agents were also identified in the red pigment. (See the specific characteristics of the different pigments described above.)

**Fig. 10.** Red Colour, red earth, carbon black: a - Observation by OM (epi-illumination) (100X). Details of picture layer and mortar; b - Observation by MEB (BSE). General image; c - EDX microanalysis. Film of paint, analysis of particle: red earth, carbon black in dolomitic calcite.

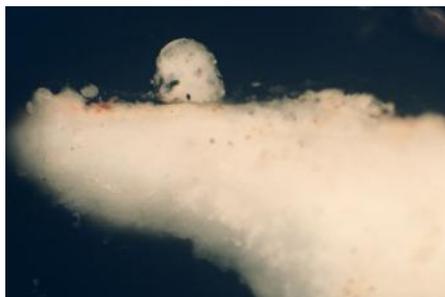
The flesh tones were monochrome, with only the occasional addition of shadow to give the impression of depth. OM showed very thin strata (20µm), with isolated (barely detectable) particles of red mixed with the lime plaster to give the pink flesh colour. SEM and EDX analysis confirmed that the high-density pigment was red earth, the iron oxide (Fe<sub>2</sub>O<sub>3</sub>) used in the aforementioned red pigment being bound with calcium carbonate (CaCO<sub>3</sub>) from the plaster (Fig. 11).

Fig. 11. Flesh tone: Observation by OM (epi-illumination) (100X), general image

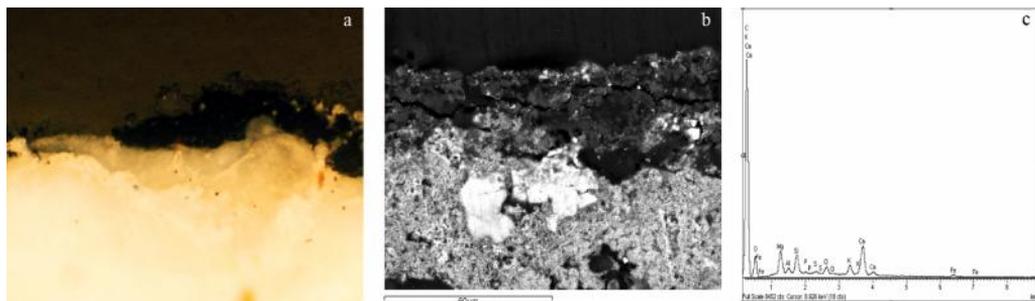
Based on the OM images, it would seem that a layer of black pigment was applied over the plaster layer, penetrating to a depth that varied from 56 to 77 $\mu\text{m}$ ). The SEM (BSE) analysis showed a pigment with low electron density, consistent with carbon black mixed with a calcite and dolomitic calcite binder. This was later confirmed with EDX analysis (Fig. 12).

Fig. 12. Black pigment: a - Observation by OM (epi-illumination) (200X). Details of picture layer and mortar; b - Observation by MEB (BSE). Details of picture layer and mortar; c - EDX microanalysis on film of paint/analysis of particle: carbon black in dolomitic calcite

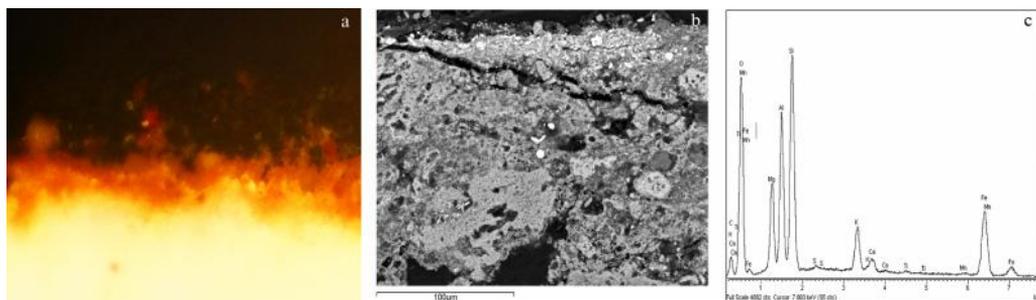
The dark brown shades used on the tree trunk and in some floral motifs on the jambs and arch were achieved using a different technique from that used to obtain dark red. In the latter case, the colour was obtained by mixing two pigments (red earth and black), while in the case of the brown shades, OM examination showed that these consisted of two layers of paint. The first layer, which penetrated to a depth of 20 $\mu\text{m}$ , is reddish in colour, while the second layer is black, with a depth of 10 $\mu\text{m}$ . The combination of these two layers gave the brown shades seen in the murals. Under SEM, the red pigment was seen to have a high electron density, while that of the black was low, with isolated high-density particles. EDX analysis (potassium, iron, sulphur, magnesium, silica) of the paint layer showed the presence of iron, specifically jarosite [ $\text{KFe}_3(\text{SO}_4)_2(\text{OH})_6$ , potassium sulphate and basic hydrated iron] mixed with raw sienna ( $\text{Fe}_2\text{O}_3$ , iron oxide with silicic acid and manganese oxide) [9]. The binding agent used is dolomitic calcite (Fig. 13).

**Fig. 13.** Brown shades: ochre, raw sienna, carbon black: a - Observation by OM (epi-illumination) (500X). Details of picture layer and mortar; b - Observation by MEB (BSE). Details of picture layer; c - EDX microanalysis on film of paint/analysis of particle: ochre, raw sienna, carbon black.

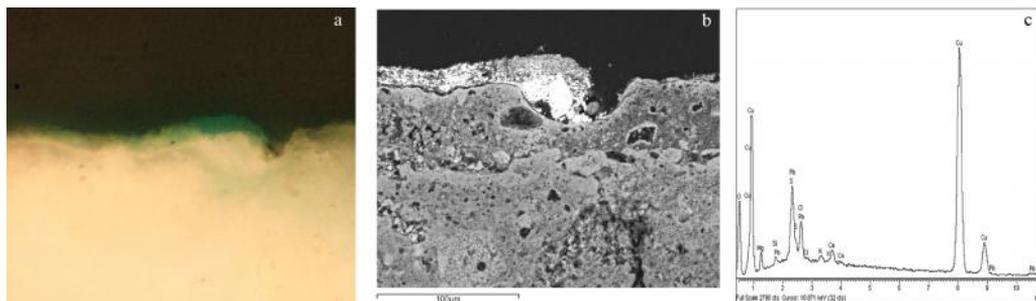
Under OM analysis, we observed that a layer of green, obtained by mixing green and white, had been applied to the plaster layer, penetrating to a depth of 35-40µm. This green pigment showed high electron density on SEM (BSE). EDX analysis showed the presence of copper and lead, amongst other compounds. This allowed us to identify both a copper and a lead pigment: malachite (copper hydroxy carbonate  $[\text{Cu}_2(\text{CO}_3)(\text{OH})_2]$ ), and lead white or basic lead carbonate  $[\text{Pb}_3(\text{CO}_3)_2(\text{OH})_2]$  (Fig. 14).

**Fig. 14.** Green: a - Observation by OM (epi-illumination) (100X). Details of picture layer and mortar; b - Observation by MEB (BSE). Details of picture layer; c - EDX microanalysis on film of paint/analysis of particle: malachite and lead white.

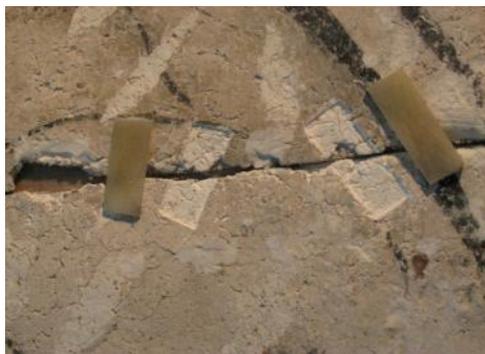
**Fig. 15.** Assembly system of the two sections of the back panel.  
wedges made of synthetic material: fibreglass and epoxy resin fibreglass.

The two sections into which the back panel of the niche was divided were reunited by means of small rectangular wedges made of synthetic material inserted in a dovetail pattern into shallow grooves carved into the plaster surface to form a strong joint. The wedges were made of non-woven fiberglass and epoxy resin (Fig. 15).

- Fibreglass threads cut into 6mm lengths ( $\text{SiO}_2$ ): these threads are made by extruding glass to obtain extremely fine filaments that can be used in the manufacture of textiles. Fibreglass is composed of silica, lime and sodium carbonate and was introduced in the first half of the 20th century. When mixed with certain polymers, it is widely used as an insulation material in construction due to its strength and transparency [23].

- Epoxy resin EPOFER EX 402 + E 430 (ratio 100:30 pbw): a thermal stable polymer that hardens when treated with a catalyst. Glass transition temperature:  $90^\circ\text{C}$ . Density at  $25^\circ\text{C}$ :  $1.11\text{g/cm}^3$  (EX 402) and  $0.99\text{g/cm}^3$  (E 430). Viscosity at  $25^\circ\text{C}$ : 1700 (EX 402) and 80 (E 430). The epoxy resin chosen for this restoration project was a special UV resistant, totally transparent formulation, two characteristics that were essential for the nature of the restoration work carried out [24].

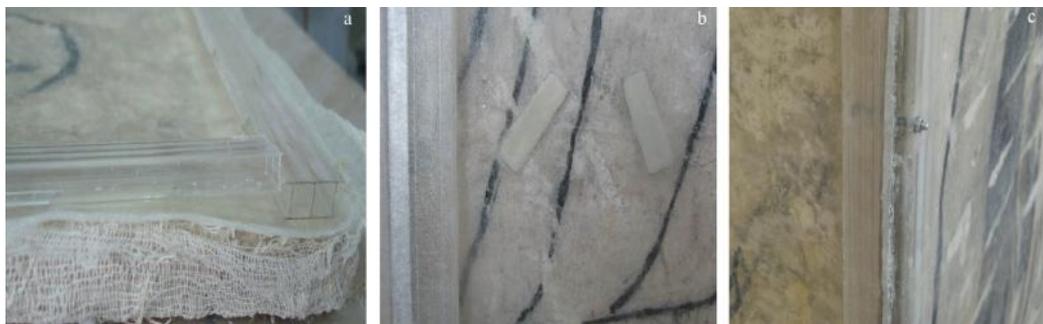
**Fig. 16.** Frame alveolar polycarbonate: a - Reinforcement frame of alveolar polycarbonate with longitudinal cells measuring 4 x 1cm in cross-section; b - Detail of anodized aluminum bars into the polycarbonate structure; c - System assembly of the main structure: screwed to small plates attached to the polycarbonate frame.

Following this, we constructed a frame using alveolar polycarbonate with longitudinal cells measuring 4 x 1cm in cross-section (Fig. 16a), through which hollow, square-section (0.8 cm<sup>2</sup>) anodized aluminum bars were inserted (Fig. 16b). The frame was attached to the structure by means of epoxy resin and fiberglass, without touching the painted areas. By this means, the impression left by the earlier painting on the back of the later fresco remained clearly visible. The same system was used to frame the later back panel of the niche (with paintings on both sides), the two jambs, and the arch.

The panels were then assembled on a scaffold made of L-shaped aluminum bars. This support structure was screwed to small plates that had previously been attached to the polycarbonate frame and the enclosed aluminum bars (Fig. 16c). As the reverse of the original back panel of the niche did not contain any artwork, it was attached to a frame made of rectangular-section aluminum bars (4cm<sup>2</sup>) by means of epoxy resin and fiberglass.

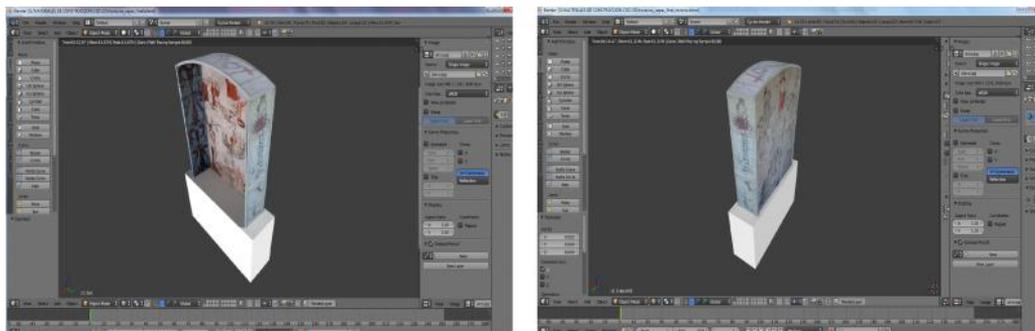
Fig. 17. 3D virtual reconstruction of the whole with Blender program

The use of the latest observational technologies gives valuable, in-depth insight into our cultural heritage, and thus contributes to saving historical treasures. The use of 3D photogrammetry is essential to enable such large restoration projects to be adequately viewed and enjoyed (Fig. 17).
