SUSTAINABILITY OF ARCHITECTONIC CONSERVATION YARDS IN ENVIRONMENTAL PROTECTED AREAS: THE CASE OF THE ZÉNOBITO TOWER IN CAPRAIA ISLAND

Fabio FRATINI^{1*}, Daniela PITTALUGA²

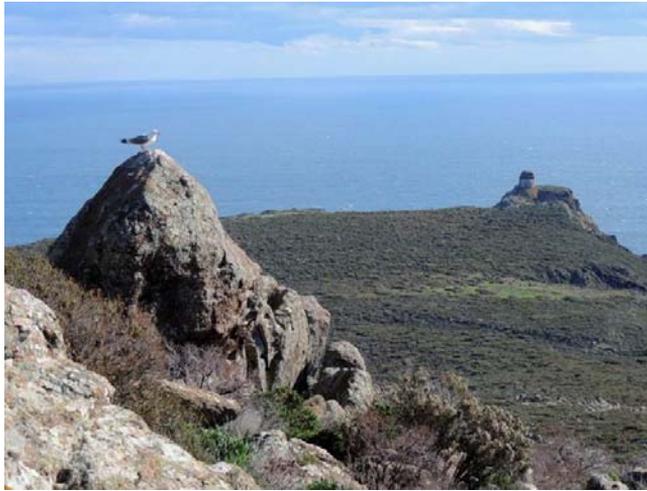
Fig. 1. The southern tip of Capraia Island with the Zénobito tower

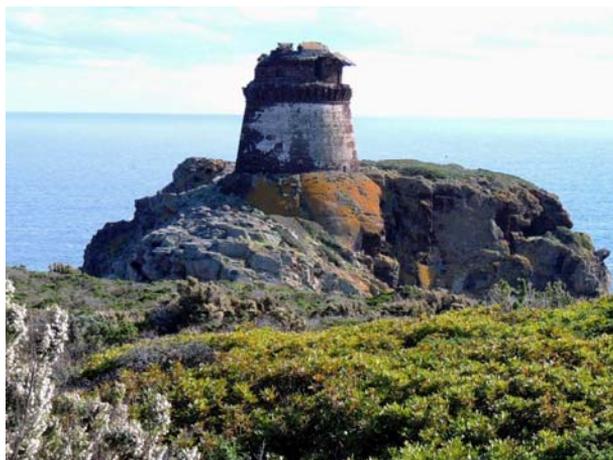
Currently the tower, which has no static problems, shows important remains of the plaster coating, still characterized by good adhesion to the wall (Fig. 2).

Fig. 2. The shape of the tower with the plastered conical base and the overlying cylindrical body with the corbels that supported a gallery

The plaster over the masonry is missing in large parts of the tower, the action line is to keep it unmodified, because the masonry under it seems to be at “quasi-equilibrium”.

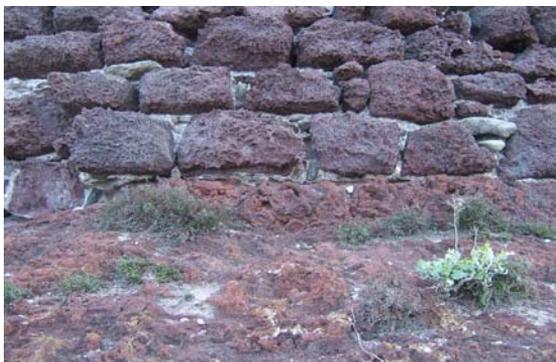
This was achieved in a structure based on two walls, an outer and an inner one, linked by a core element. The outer wall is composed of blocks of volcanic rock, roughly shaped and put in place with a rich mortar, made necessary by the irregularities of the same blocks (Fig. 3).

This masonry still shows good cohesion, even if the mortar joints are deeply eroded. Only on the southeast face, a well-defined portion of the external wall fell, uncovering the wall core structure (Fig. 4). Therefore the major preservation problems are in this area and in the upper part of the cylindrical body where the corbels that supported the gallery (no longer present) are deeply eroded and in some cases missing at all. These areas definitely need a restoration that allows stopping the progress of decay mainly due to marine-salts crystallization with the consequent fall of stone elements, but this must be a localized, "non-invasive" minimal intervention. In this regard, from great nineteenth century masters of restoration to recent claims of some contemporary restoration theorists, a common line of thought states that an area that displays and maintains the *patina* of time proves to be a very interesting element, worthy of being kept and maintained [4-11]. Moreover, when an architectural surface is in a state of "quasi-equilibrium", i.e. then the degradation progress is negligible, the non-intervention is preferable [12, 13]. All these concepts have been considered in this project (F.F.).

Fig. 3. The masonry made of volcanic rock blocks roughly shaped and put in place with an abundant mortar, made necessary by the irregularities of the same blocks

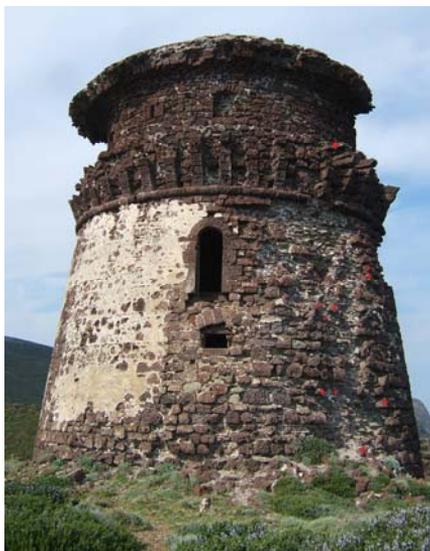
Fig. 4. In the conical base, left side of the image, remains of the covering plaster still with good adhesion of the masonry, are visible; on the right side it is evident the zone where a portion of the external wall fell, uncovering the wall core structure. With red asterisks are marked the stone blocks that in 2010 were still on site and that in the 2013 survey fell down.

Another debate issue is *whether to reconstruct the masonry or not*. The conspicuous lack of material in the south-east masonry, which has been mentioned above, should be carefully analysed in the phase that anticipates the construction yard itself. Today, as a matter of fact, it is not yet clear whether it is simply deterioration or it comes from human activity, for example a cannon shot. This must be understood.

In case of artificial origin the lack should be described in stratigraphic analysis, but it should not be filled again, because the lack itself is an historical document; intervention should be restricted to safety issues, i.e. avoiding falls of materials and injuries to people below.

The main reason in favour of a reconstruction of the missed masonry is the risk of further decay of the structure in absence of such a reconstruction. In case the current state has not an artificial origin, but it is the result of a natural decay, all these pros and cons of an intervention should be evaluated, after an initial study that investigates why the lack has such a narrow extension, the relation to changes in materials or microclimate, for example wind prevailing direction.

If the intervention will be decided, this would be easy to read and distinguish from original parts. New mortar, for example, should distinguish itself from original one; this would be easily obtained because in Italy it is illegal to use marine sand to make mortar, as they did in these times. The hidden masonry wall inside should be photographed before being hidden again, and photos should be exhibited in a museum, for example in the second tower near the village.
