THE CONTRIBUTION OF EARTH SCIENCES TO THE PRESERVATION OF UNDERWATER ARCHAEOLOGICAL STONE MATERIALS: AN ANALYTICAL APPROACH

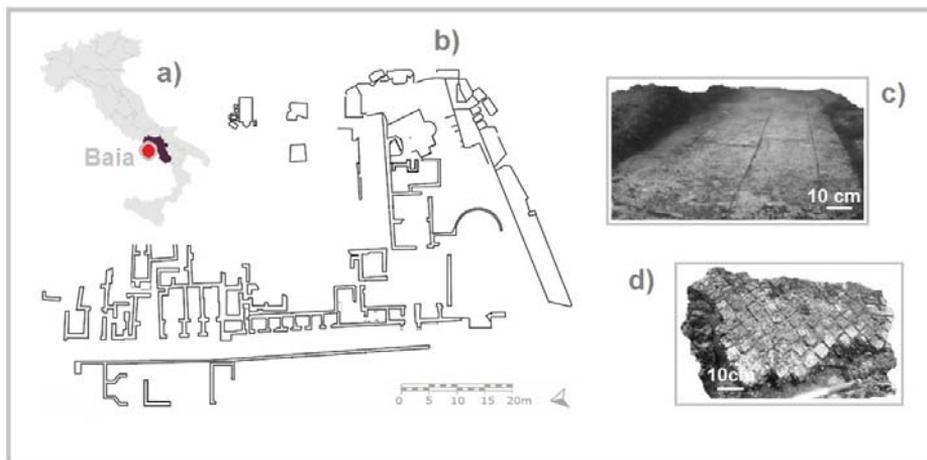
Fig. 1. a) Location of Baia in the Campanian region, Italy**; b)** Plan of the *Villa con ingresso a protiro*;
c) and **d)** Portions of the *covering slabs* belonging to the Villa.

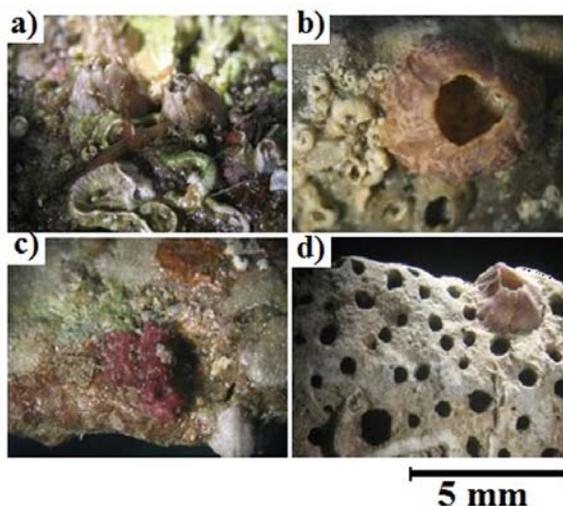
Some marble specimens (Table 2) show a slight biological growth characterized by thin superficial deposits, while others exhibit a great colonization in which, in addition to superficial concretions, bioerosion phenomena can also be observed. The presence of surface deposits is due to epilithic encrusting organisms (whose rate of coverage in all samples ranges from 5 to over 75%), mainly consisting of serpulids (Fig. 3a) and algae (Fig. 3c), and subordinately barnacles (Fig. 3a, b) and bryozoans (Fig. 3c). All these organisms produce carbonate deposits associated to their skeletons with variable thicknesses [4, 5, 21-23]. Furthermore, in several samples, a loss of material relating to the action of endolithic communities was observed (Fig. 3d). This phenomenon is mainly produced by organisms which develop and grow-up within the stone material [13, 15, 21, 24-26]. However, only a few endolithic organisms were recognized

under stereomicroscope, such as some algae and molluscs, causing pitting and macro-boring. Even in this case, the coverage rate ranges from ~ 5 to over 75% among the specimens.

Fig. 3. Stereomicroscope photographs showing the surface colonization:
a) Calcareous skeletons of marine worms and barnacles;
b) Ventral view of a conical calcareous shell of barnacles and marine worms;
c) Encrusting red and green algae and bryozoa;
d) Bioerosion phenomenon related to endolithic sponges.

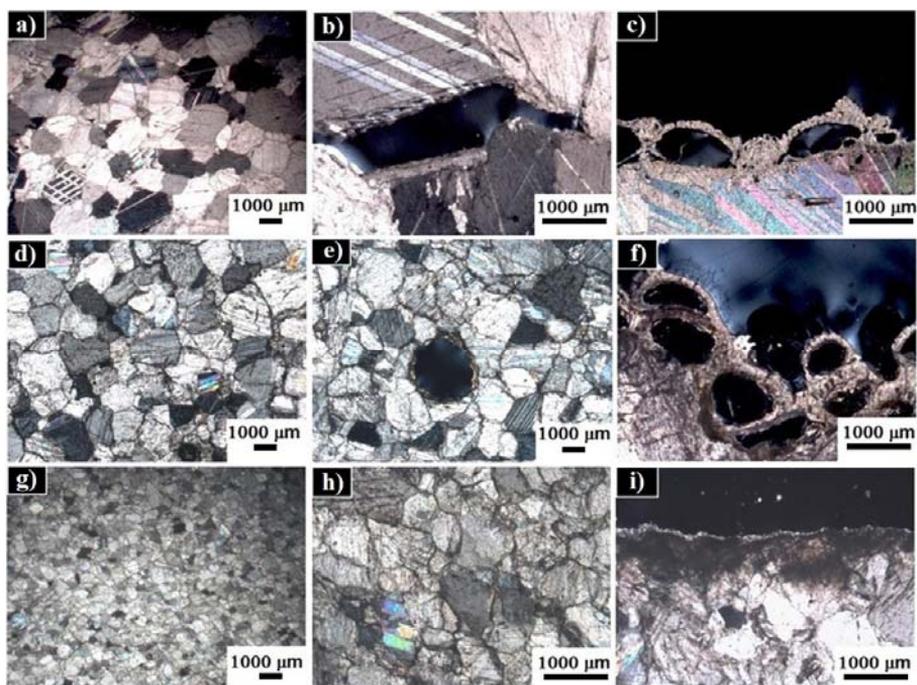
Regarding the degradation forms, petrographic observations allowed to point out some differences in relation to the grain size of samples. Specifically, the coarse-grained marbles show pronounced bioerosion phenomena consisting of pitting and macro-boring (Fig. 4a, f). Conversely, the fine-grained marbles are less sensitive to biological activity of endolithic species and are mainly interested by the development of layers (with variable thickness) on the surface (Fig. 4g, i).

Fig. 4. Representative photomicrographs in cross polars light of different marble samples analyzed: **a)** coarse-grained marble (sample MV19) with microcracks **(b)** along grains and irregular and heterogeneous superficial layer **(c)**; **d)** coarse-grained marble (sample MV24) with boring phenomena **(e)** and irregular superficial layer **(f)**; **g)** fine-grained marble (sample MV48) with absence of perforation **(h)** but only a superficial and regular layer **(i)**.

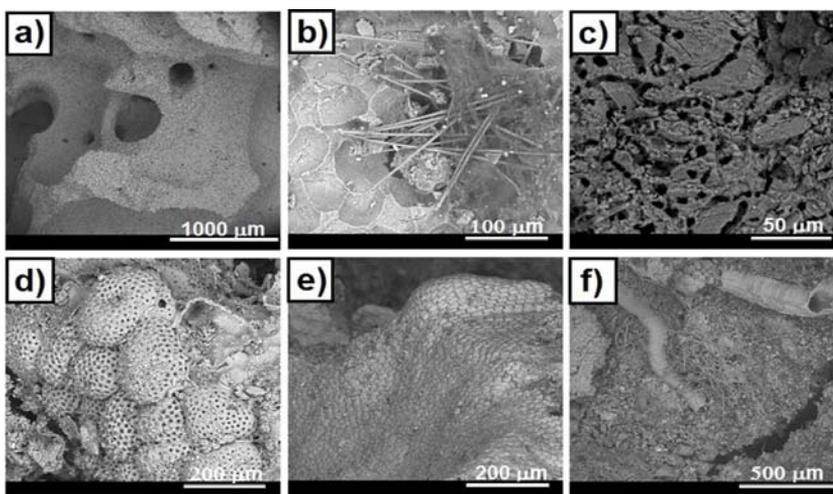
Bioerosion phenomena have been identified in different intensity, size and shape among the fifty marble fragments. The distribution of the damage is quite irregular since tunnels and cavities at times appear isolated, while in other cases seem to cluster next to each other, with diameters exceeding 500 μm.

The most frequent bioerosion structures are those related to the activity of endolithic sponges (Fig. 5a, 5b) and bivalve molluscs (as regards the marine fauna), while less invasive are those related to algal colonisation (marine flora). All these organisms were recognized through the identification of skeletal and inorganic structures, calcareous or siliceous, or by studying their footprints left inside the stones.

Fig. 5. SEM images of skeletal components and bioerosion phenomena on marble fragments:
a) Sponge cavities; b) Sponge spicules and footprints; c) Micro-perforations;
d) Bryozoa scheletal components; e) Algae flattened thalli; f) Marine worms.

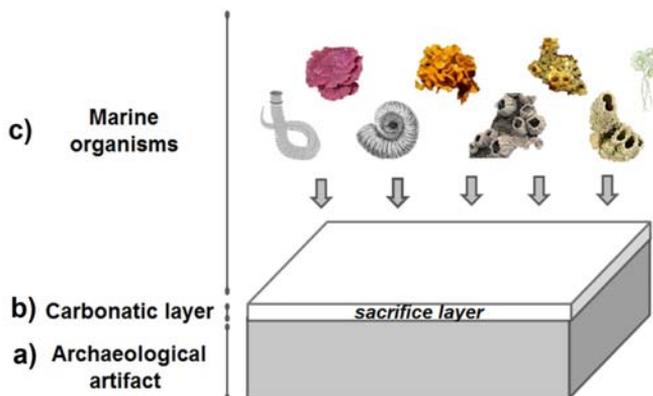
Regarding the action of encrusting species, the phenomenon seems to be quite complex. In this case, dealing with superficial colonization, the same organisms previously recognised by stereomicroscope were also detected through SEM. However, their morphological features were observed in more detail. All the marine organisms with a calcareous skeletal component (Fig. 5d, e, f) tend to cover the colonized surface with carbonate layers whose thickness is highly variable depending on the species (usually from 50μm to 3 mm). These layers blight the archaeological artefact, losing its legibility and functionality. Therefore, the result is a strong aesthetic damage. Paradoxically, some authors (e.g. [4-5]) demonstrated the protective action of these carbonate layers on the surface, a phenomenon well known as *bio-protective effect*, schematized in Figure 6. When some species reach the life cycle, what remains on the archaeological surface is their inorganic component which is mainly of carbonate nature. These

new thicknesses, called "sacrifice layers", become the new areas colonisable by marine organisms. The protective effects of these carbonate layers will strictly depend on the different biological communities that will act on them over time.

Fig. 6. Schematization of the "sacrifice layers" developing on archaeological items.

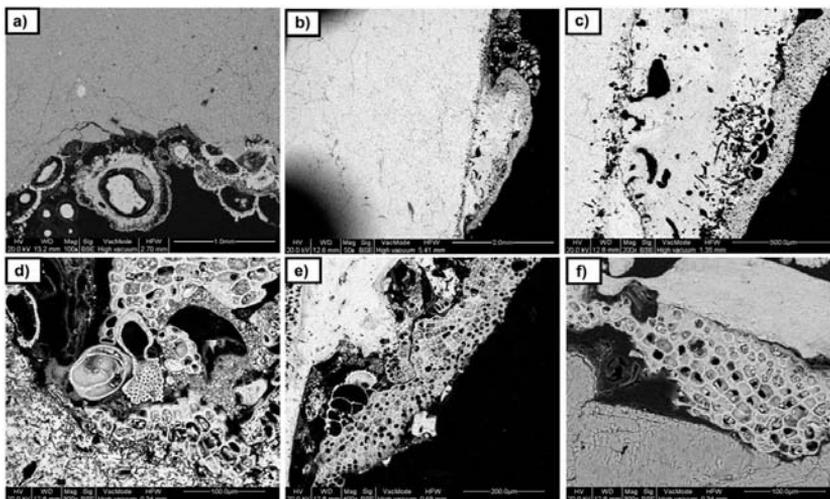
Fig. 7. SEM images of the encrusting deposits on the substrate: **a)** Irregular and heterogeneous carbonatic layer; **b)** Interaction patina-substrate; **c), d, e)** and **f)** Detailed transversal sections showing flared epithelial cells and cell fusions of red algae, gastropods shells, bryozoans and micro- and macro-boring phenomena.

The superficial deposits reveal thicknesses ranging between 0.05 and 3 mm as well as very heterogeneous and irregular trends. Intense bioerosion phenomena, micro-cracks and penetrations into the substrate, due to biological activity, were also detected. In particular, red algae covering wide surfaces with their compact and flattened structures are shown in Figure 7, along with gastropods shells, bryozoans and micro- and macro-borings related to some sponges, algae and molluscs.
