OIL PAINTING COLLECTION: RISK ASSESSMENT, EVALUATION AND MITIGATION STRATEGIES

Mafalda FERNANDES, Sara BABO¹, Maria Filomena MACEDO^{1,2*}

Keywords: Preventive Conservation; Risk Assessment; Oil Painting; Historic House.

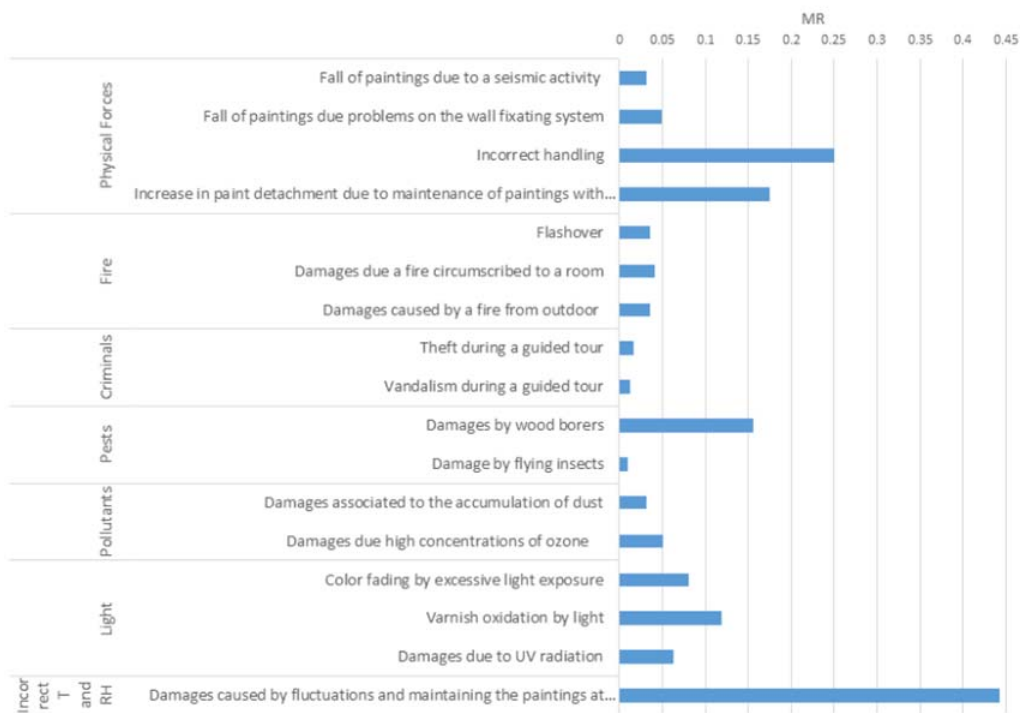
Specific risks	Type	MR
The falling of paintings due to a seismic activity	1	FS = 1, PV=0.75, P=0.917 E=0,0468 MR= 0.032
The falling of paintings due to problems of the wall fixating system	2	FS= 0.962 PV=0.75 P=1 E=0.017 MR= 0.012
Incorrect handling	2	FS= 1 PV=0.25 P=1 E=1 MR= 0.5
Increase in paint detachment due to maintenance of paintings with paint lifting on exhibition	2	FS= 0.604 PV=0.75 P=1 E= 0.387 MR= 0.176

Fig. 3. Magnitude of the main specific risks (MR) calculated for the oil painting collection on display in “Casa dos Patudos”

Since the opening of the Museum, the staff working in “Casa dos Patudos” never had training on preventive conservation or collections care; as a result some works of art were already damaged by incorrect handling. As it was reported by the staff, at least one painting has fallen due to incorrect handling. Every painting is handled on a regular basis for loans, cleaning or to apply insecticides in the frame. The loss of value is moderated because the damages will be localized and mainly on the frame. Nevertheless, this risk magnitude presents one of the highest values (Fig. 3).
